**Technical Report(TR6)****Compliance Filing # TR6-916577-9B-A1****2. Location**

| House Number | 534 | Street Name | WEST 42 STREET |

## **534 West 42nd Street**

**Amended 9th Cycle FISP Filing - Elevation Photos**

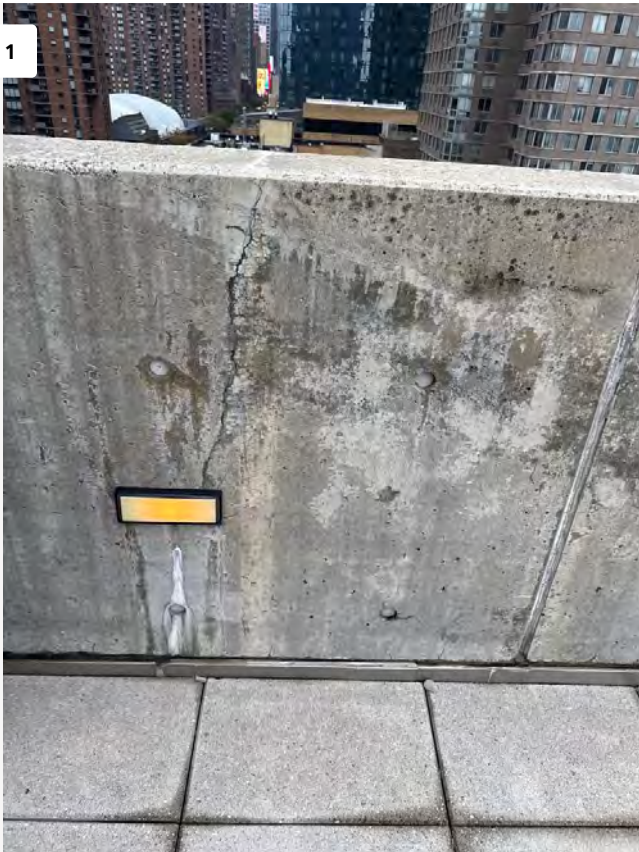
1

Typical View of Cracked Concrete at Parapet noted in Initial & Subsequent 9th Cycle FISP Report Filings.

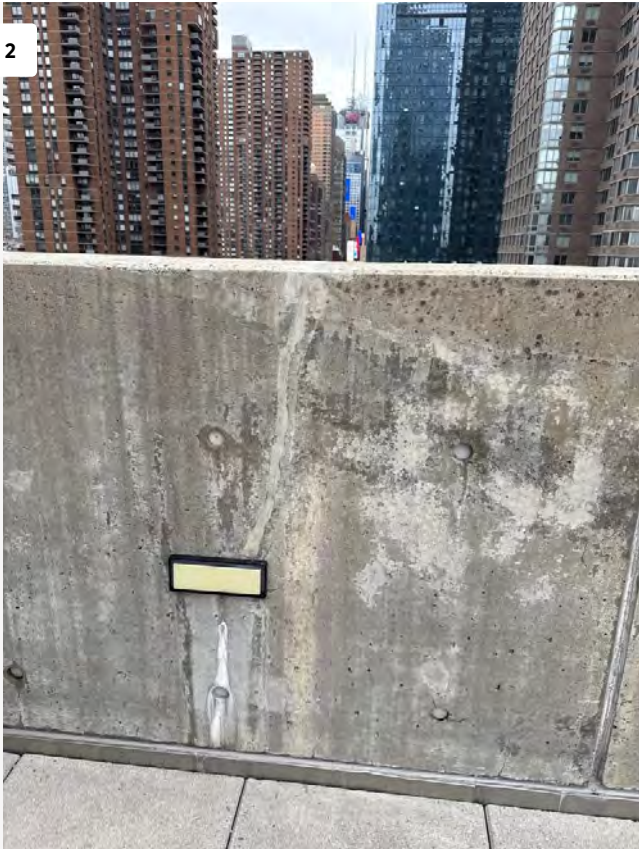
2

Typical View of Repaired Cracked Concrete at Parapet.

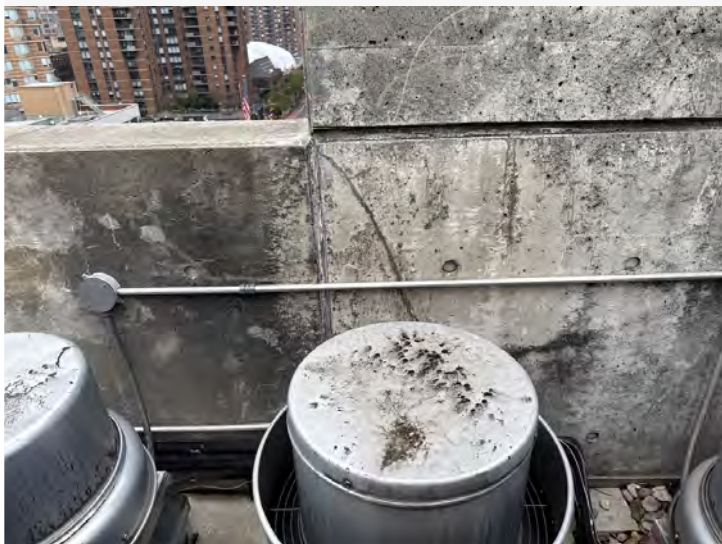
3

Typical View of Cracked Concrete at Parapet noted in Initial & Subsequent 9th Cycle FISP Report Filings.

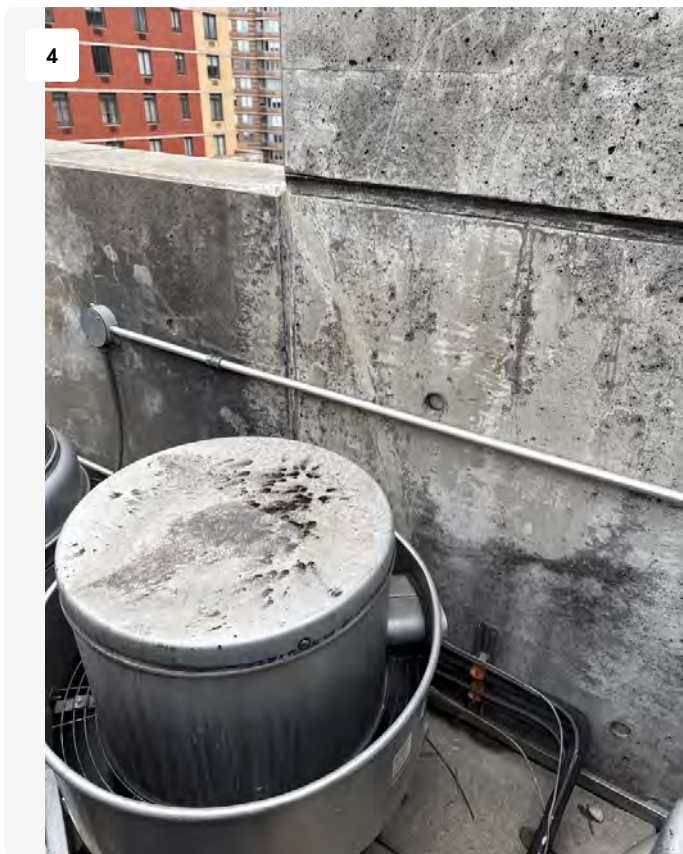
4

Typical View of Repaired Cracked Concrete at Parapet.

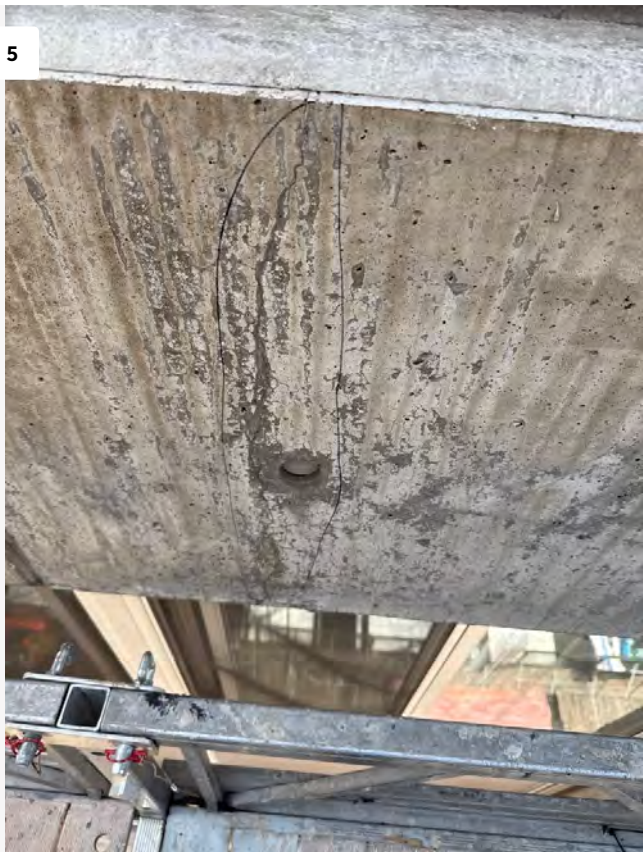
5

Typical View of Cracked Concrete at North Elevation noted in Initial & Subsequent 9th Cycle FISP Report Filings.

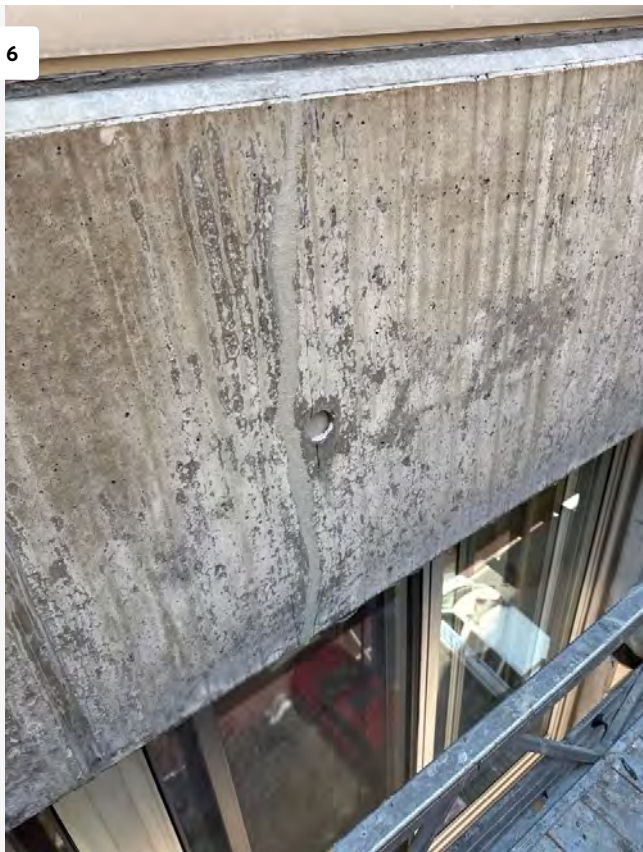
6

Typical View of Repaired Cracked Concrete at North Elevation.

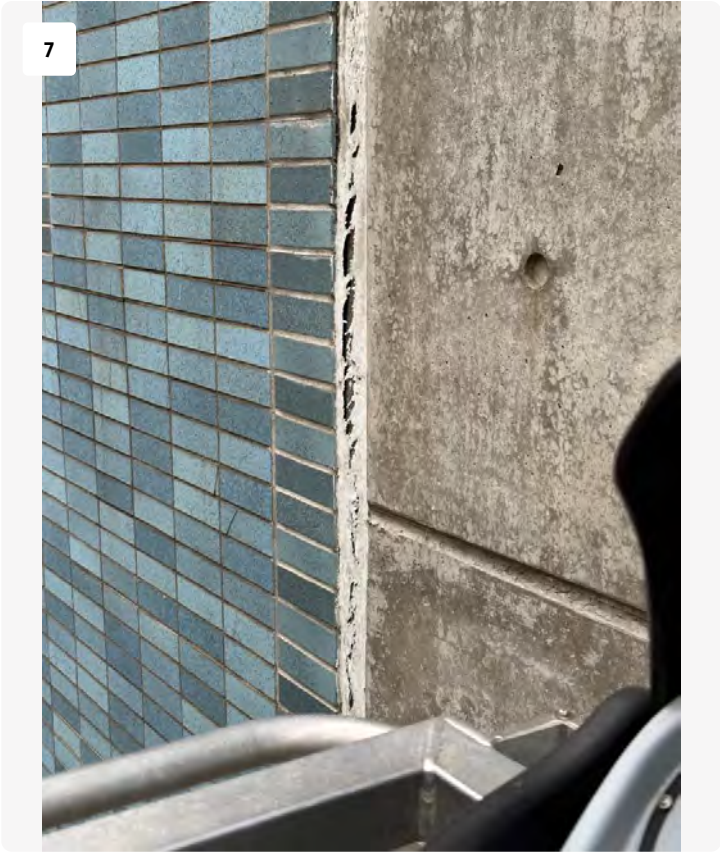
Typical View of Open Joint Sealant at North Elevation noted in Initial & Subsequent 9th Cycle FISP Report Filings.

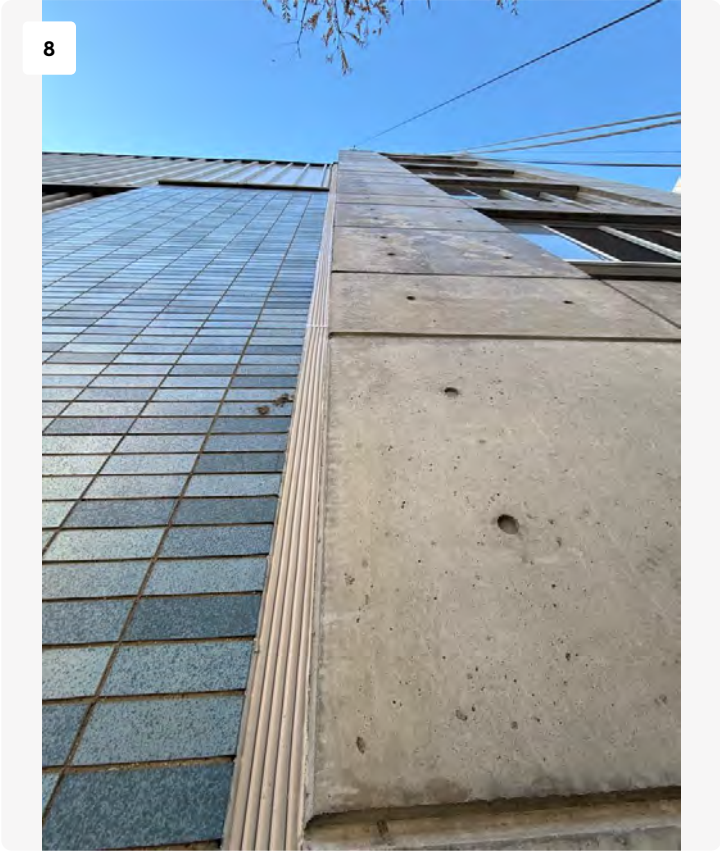
Typical View of Repaired Open Joint Sealant at North Elevation

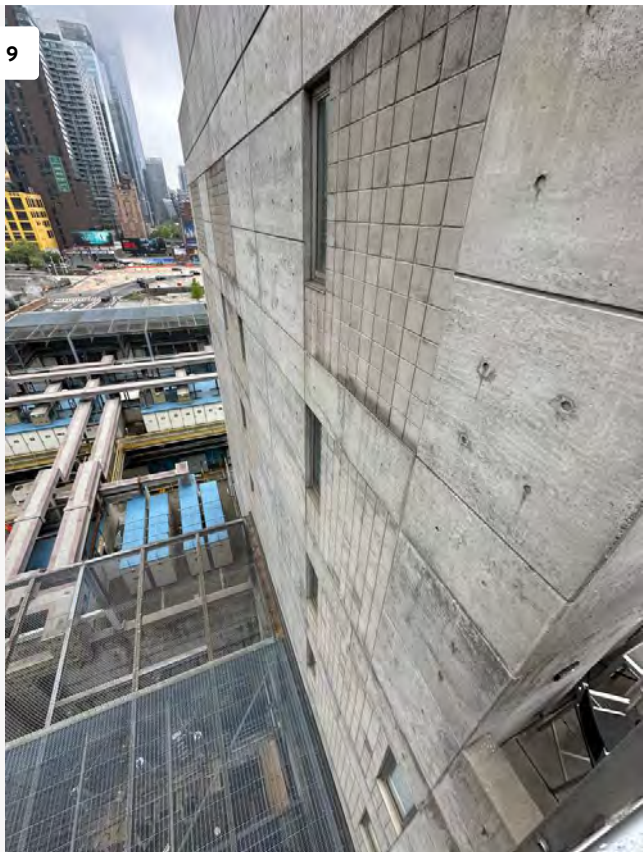
9

Typical View of Cracked Concrete at East Elevation noted in Initial & Subsequent 9th Cycle FISP Report Filings.

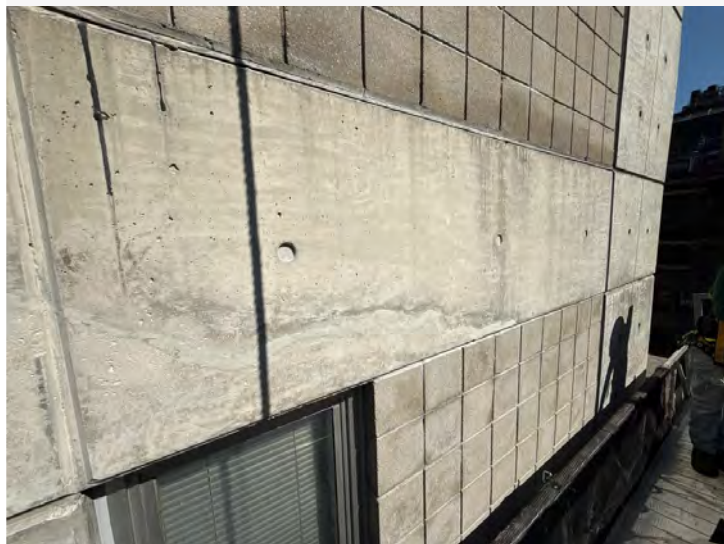
10

Typical View of Repaired Cracked Concrete at East Elevation.

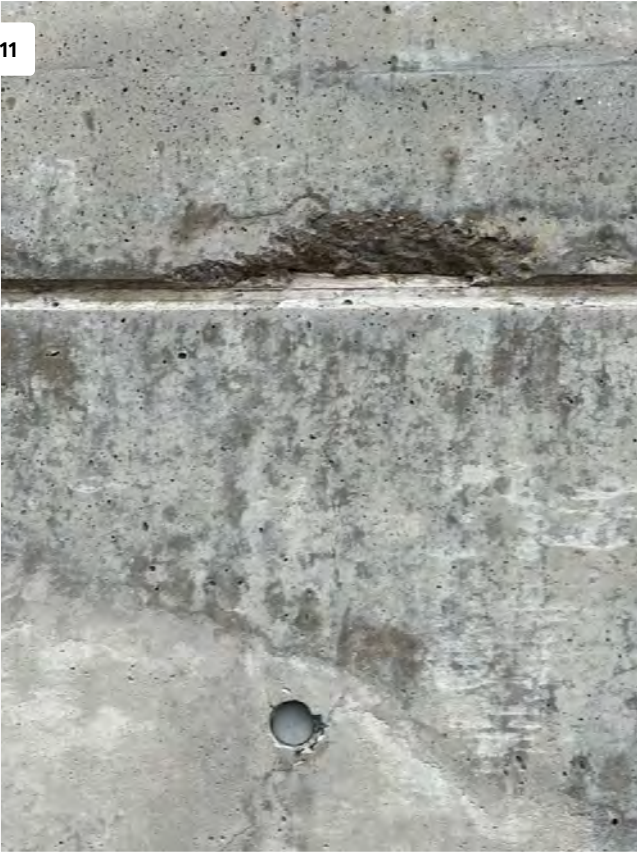
11

Typical View of Spalled Concrete at West Elevation from noted in Initial & Subsequent 9th Cycle FISP Report Filings.

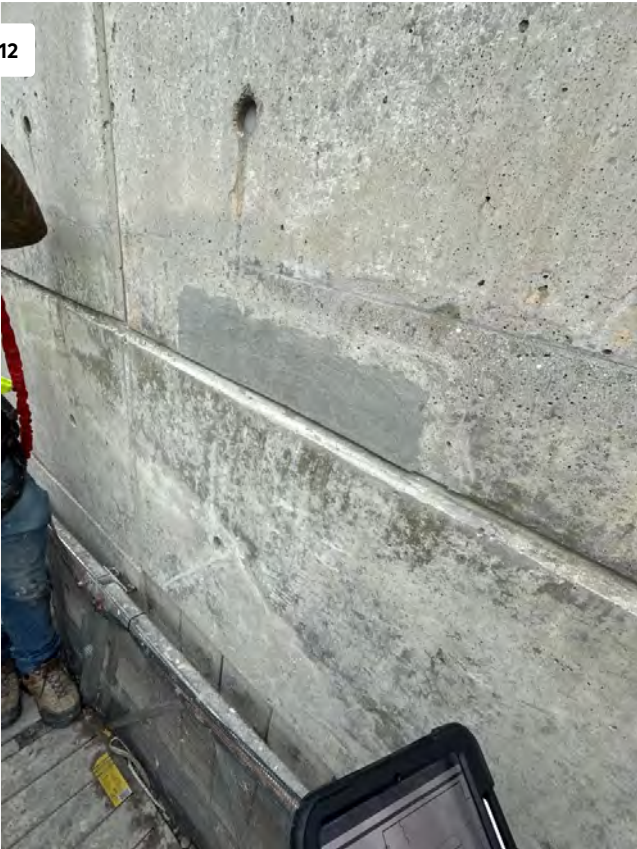
12

Typical View of Repaired Spalled Concrete at West Elevation.

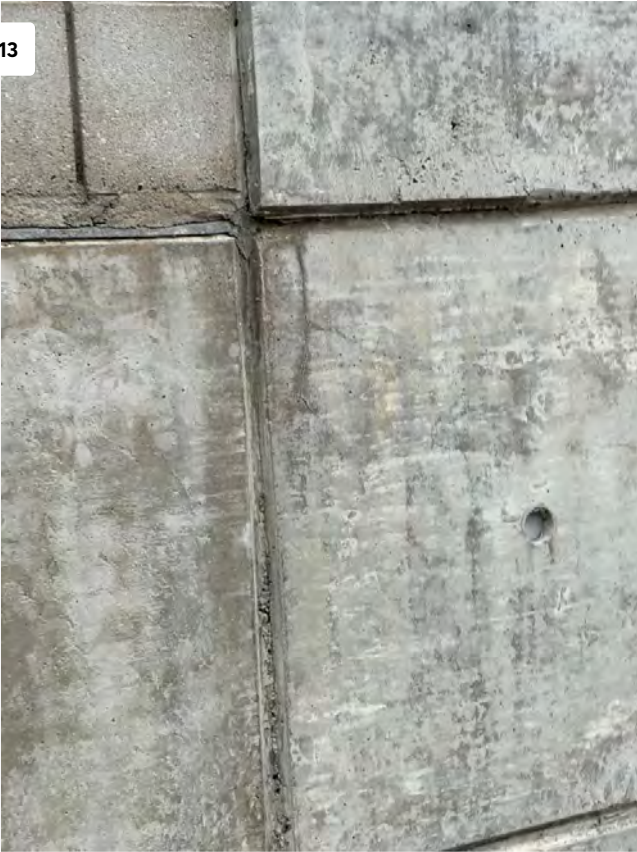
13

Typical View of Cracked Concrete at West Elevation noted in Initial & Subsequent 9th Cycle FISP Report Filings.

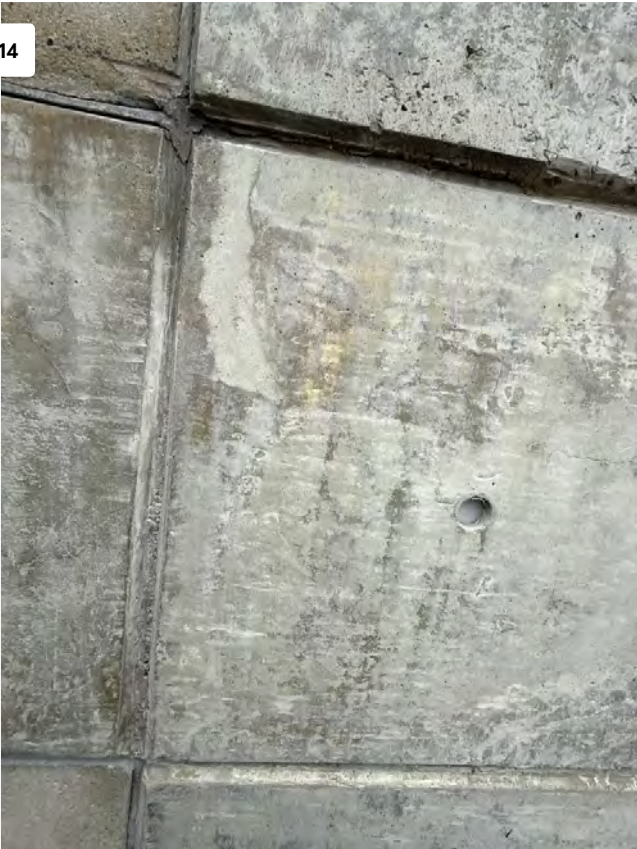
14

Typical View of Repaired Cracked Concrete at West Elevation.

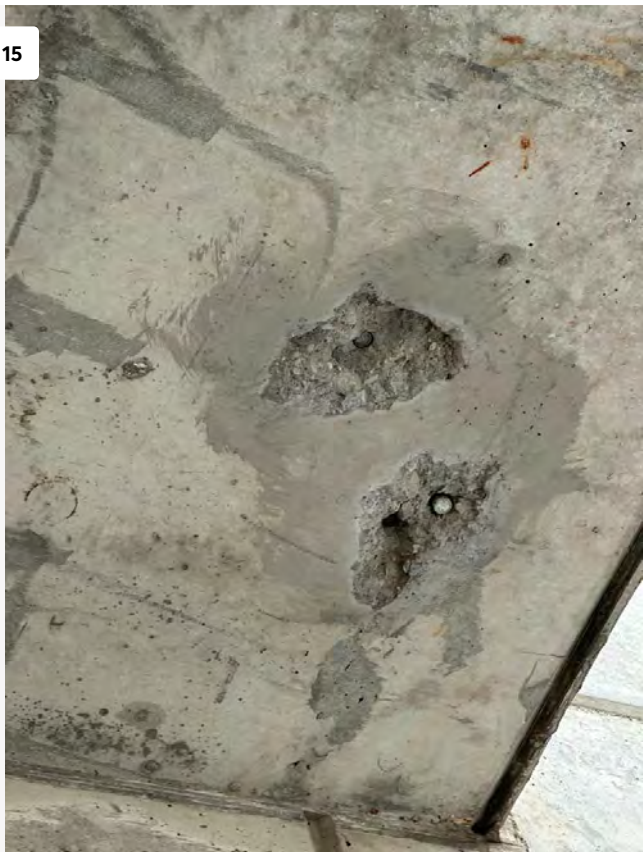
15

Typical View of Spalled Concrete at Balcony along South Elevation noted in Initial & Subsequent 9th Cycle FISP Report Filings.

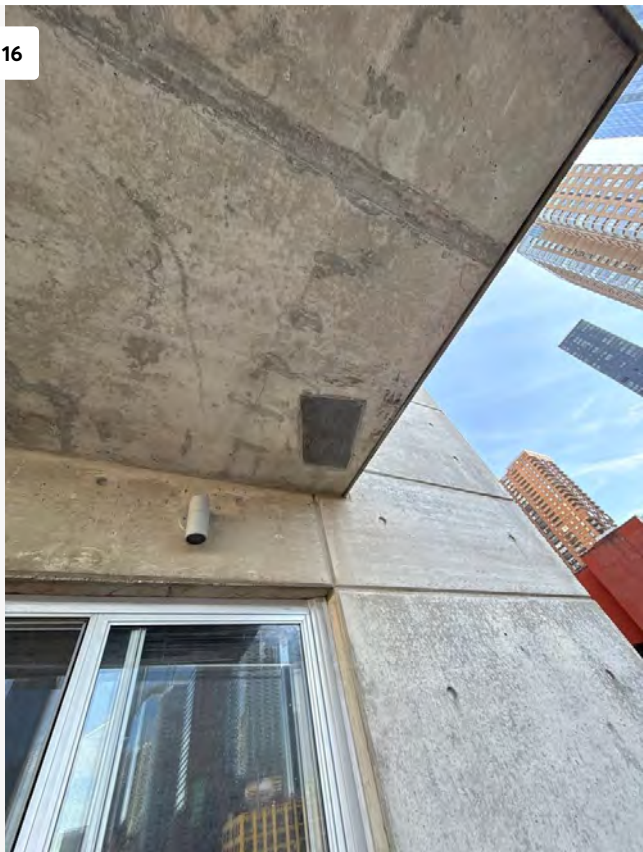
16

Typical View of Repaired Spalled Concrete at Balcony along South Elevation.

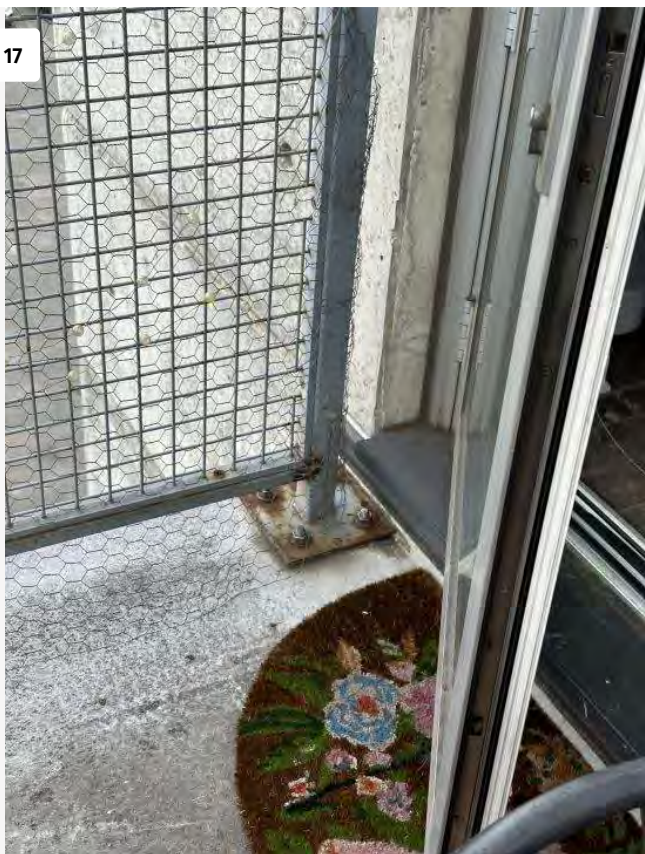
17

Typical View of Surface Rust at Balcony Railing along South Elevation noted in Initial & Subsequent 9th Cycle FISP Report Filings.

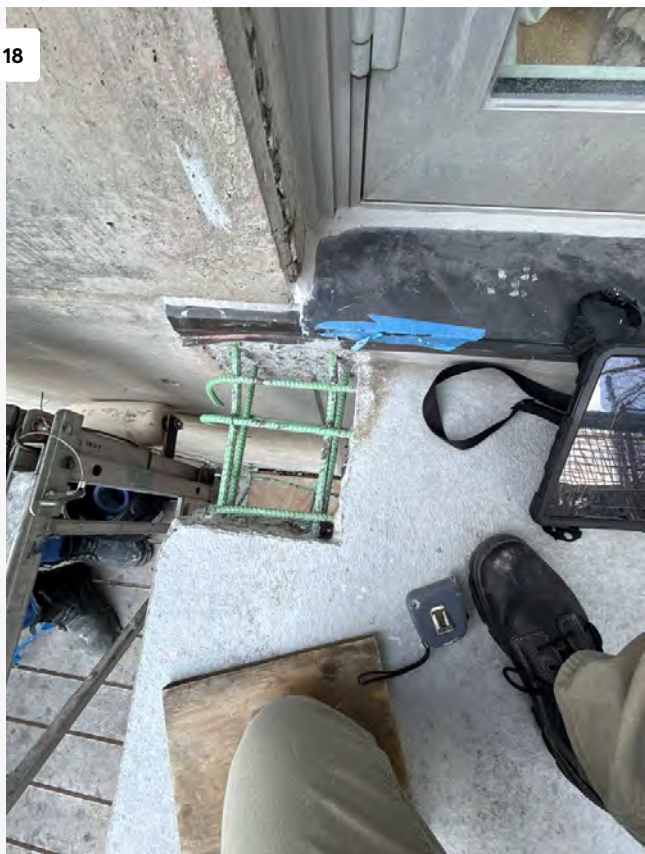
18

View of Inspection of Rebar Conducted at South Balcony during Repair Project at Building.

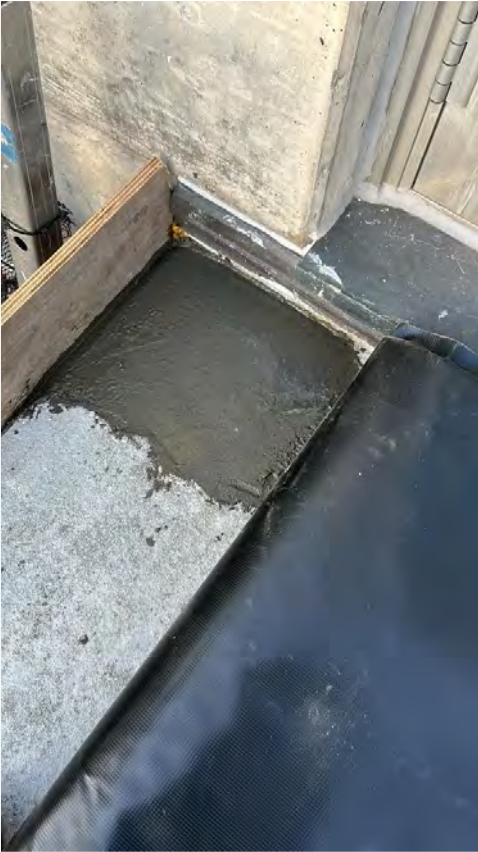
19

Typical View of Balcony Corner Repair along South Elevation.

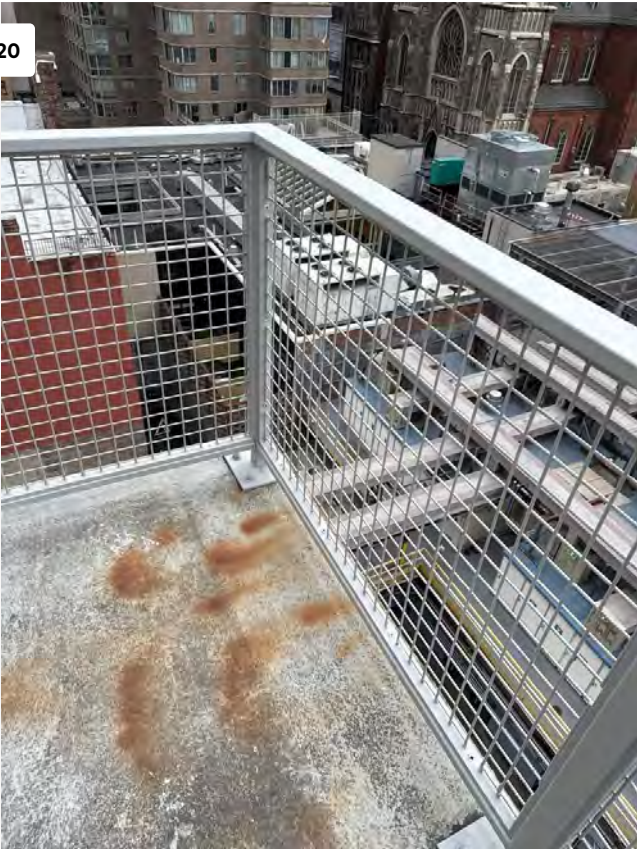
20

Typical View of Scraped, Primed, and Painted Surface Rust at Balcony Railing along South Elevation.

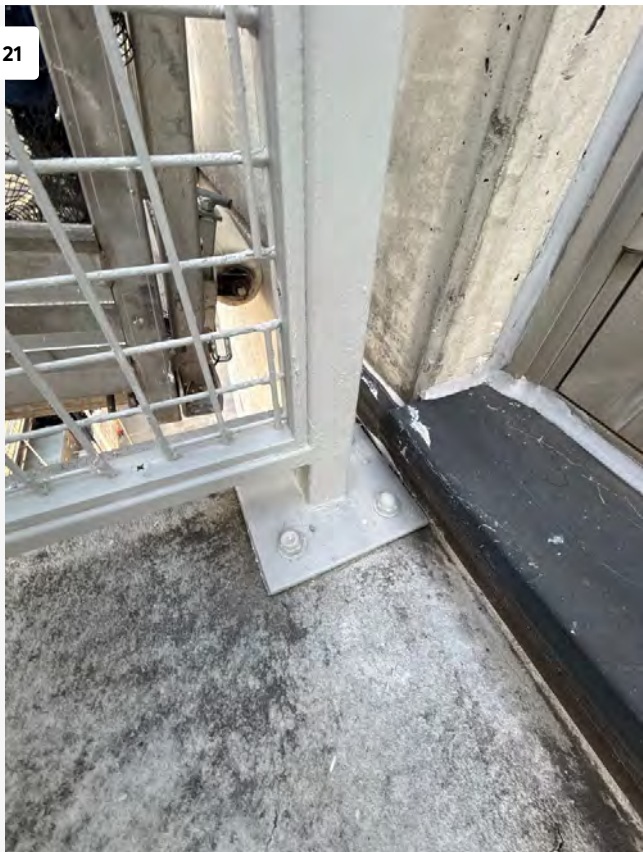
21

Typical View of Scraped, Primed, and Painted Surface Rust at Balcony Railing along South Elevation.

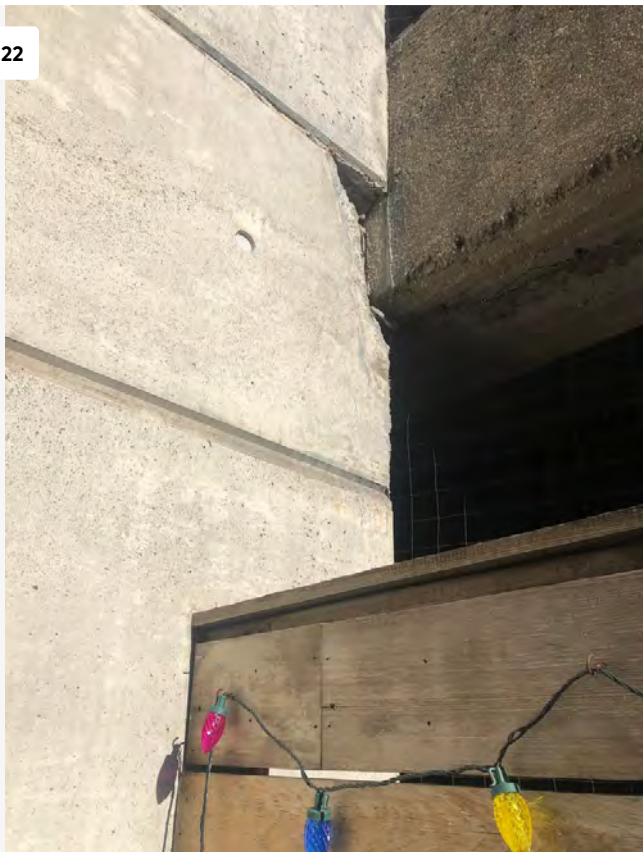
22

Typical View of Spalling Concrete at South Elevation noted in Initial & Subsequent 9th Cycle FISP Report Filings.

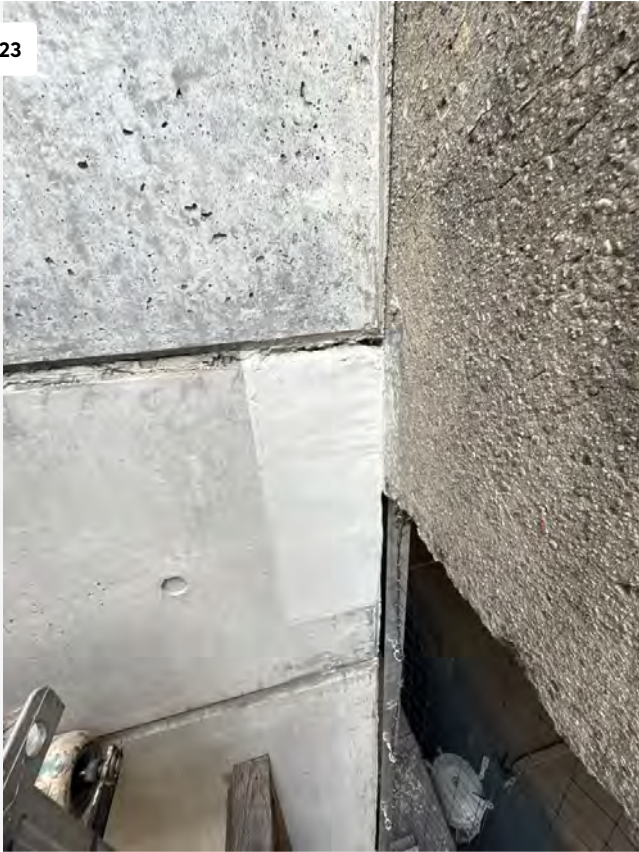
23

Typical View of Repaired Spalling Concrete at South Elevation.
