December 12, 2023

Re: Parapet Certification Letter – 534 West 42nd Street, Manhattan, NY

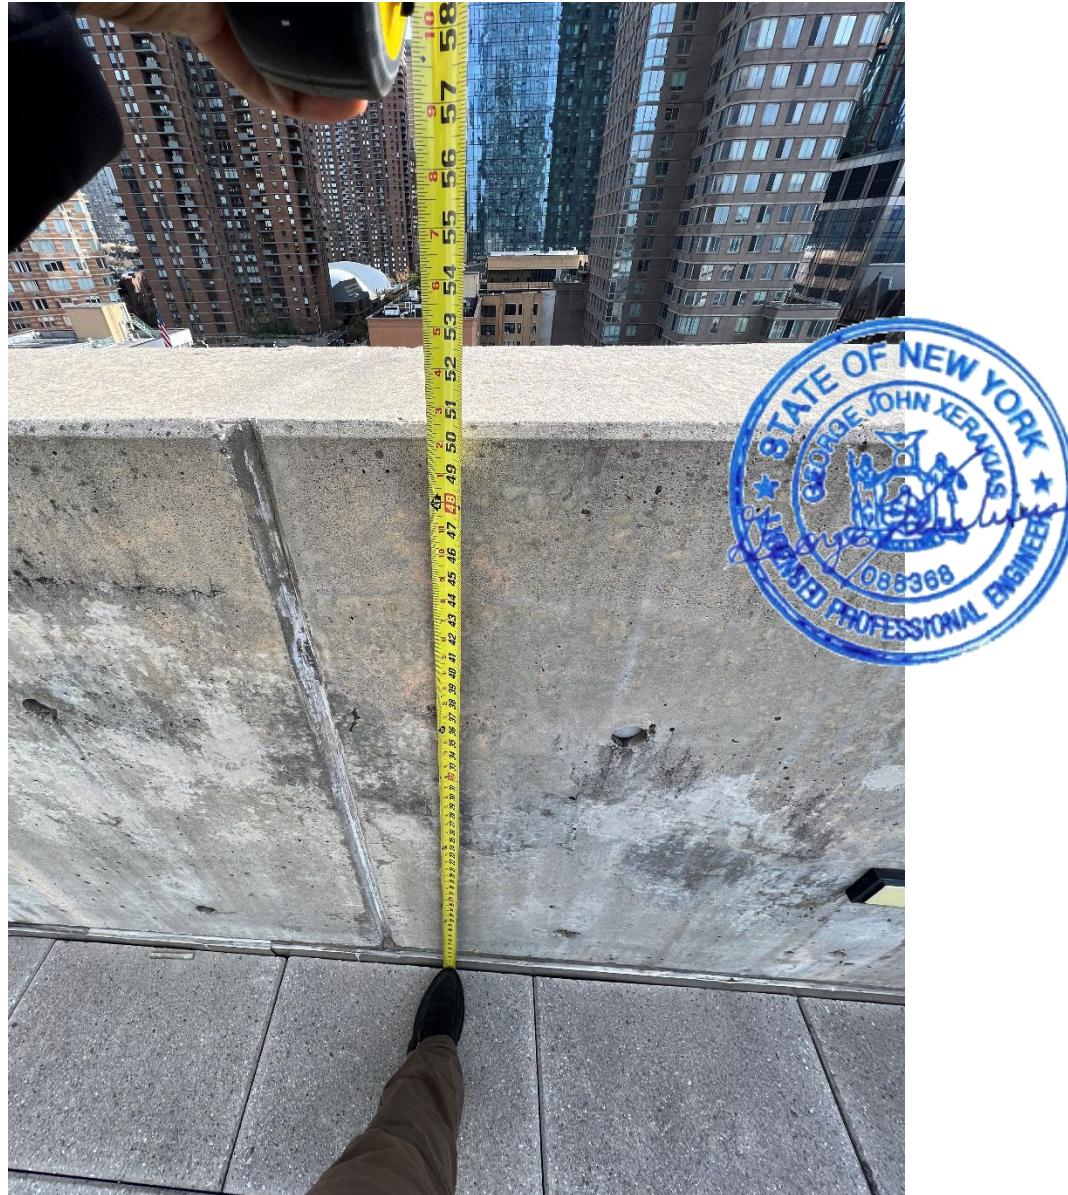
Picture 1 – Interior Parapet wall – Solid concrete wall with rebars. Approximately 50inches in height.
Typical Conditions

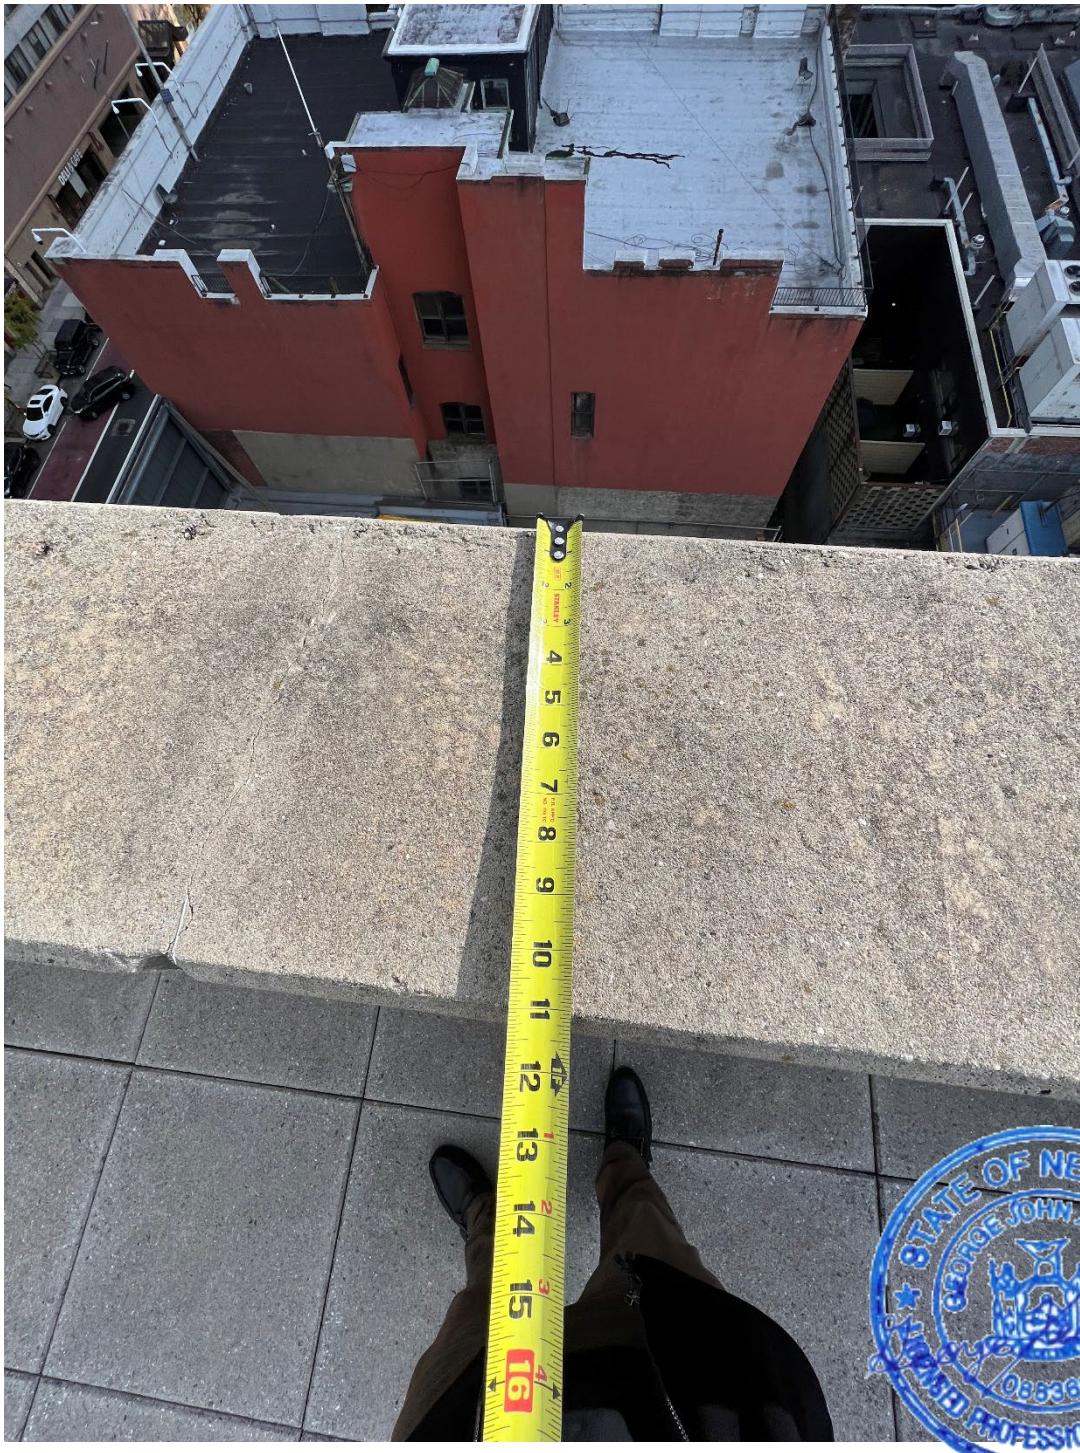
Picture 2 – Parapet wall – Solid concrete wall with rebars. Approximately 11 inches in width –
Typical Conditions.
