PROJECT  
**1005 1<sup>st</sup> Avenue, New York, NY**  
**Cycle 8 FISP Inspection**

DATE  
**September 15, 2017**

TITLE  
**Detail Photos**

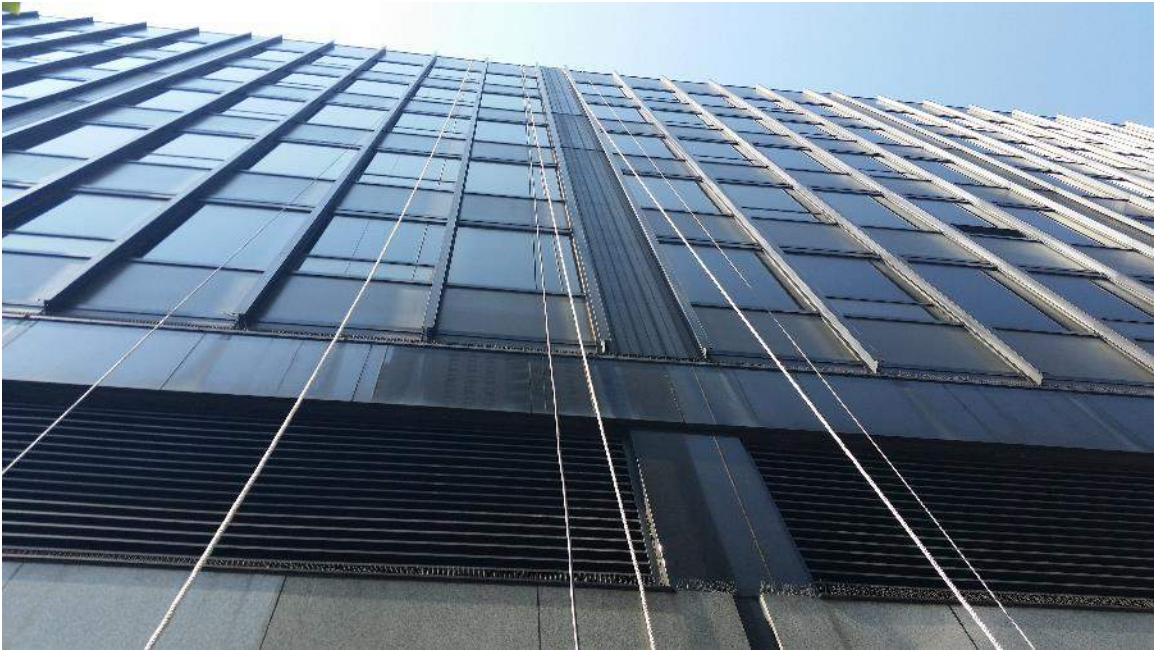
**Detail Photo No. 1** - Overall view of East Elevation from 1<sup>st</sup> Avenue.

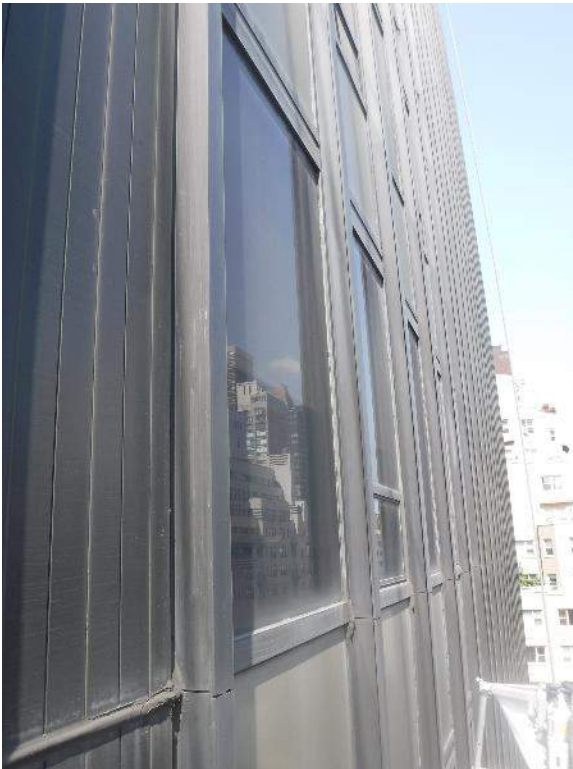
**Detail Photo No. 2** – Close-up of curtain wall on East Elevation.

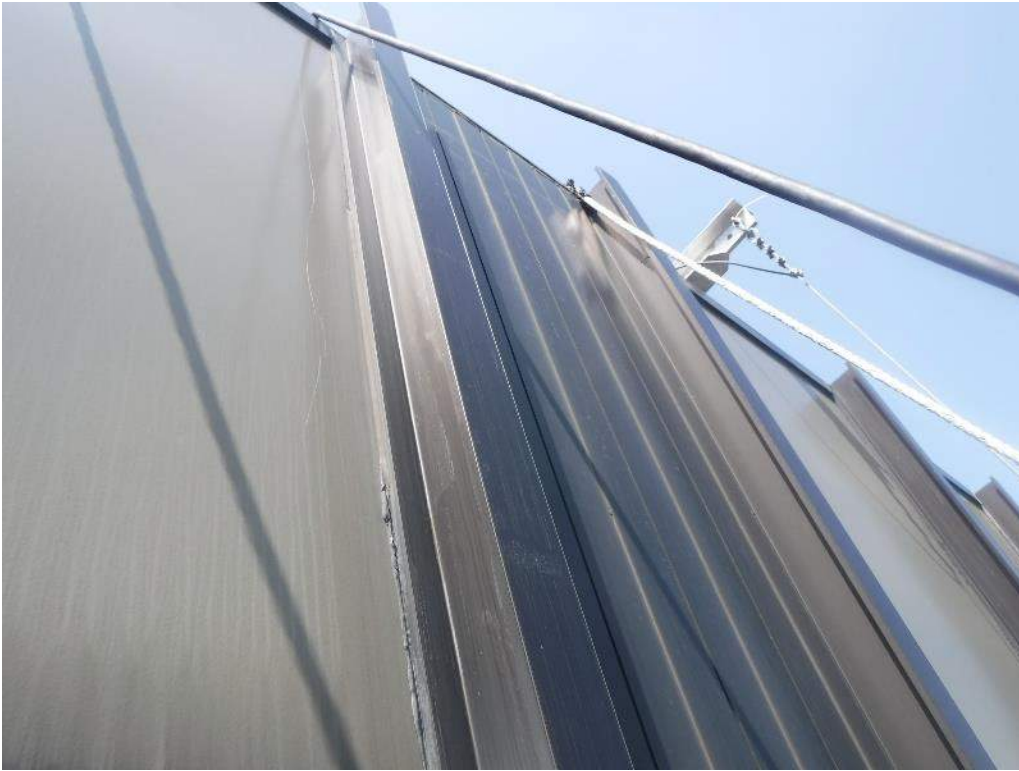
**Detail Photo No. 3** - Overall view of East Elevation parapet exterior at top of building.

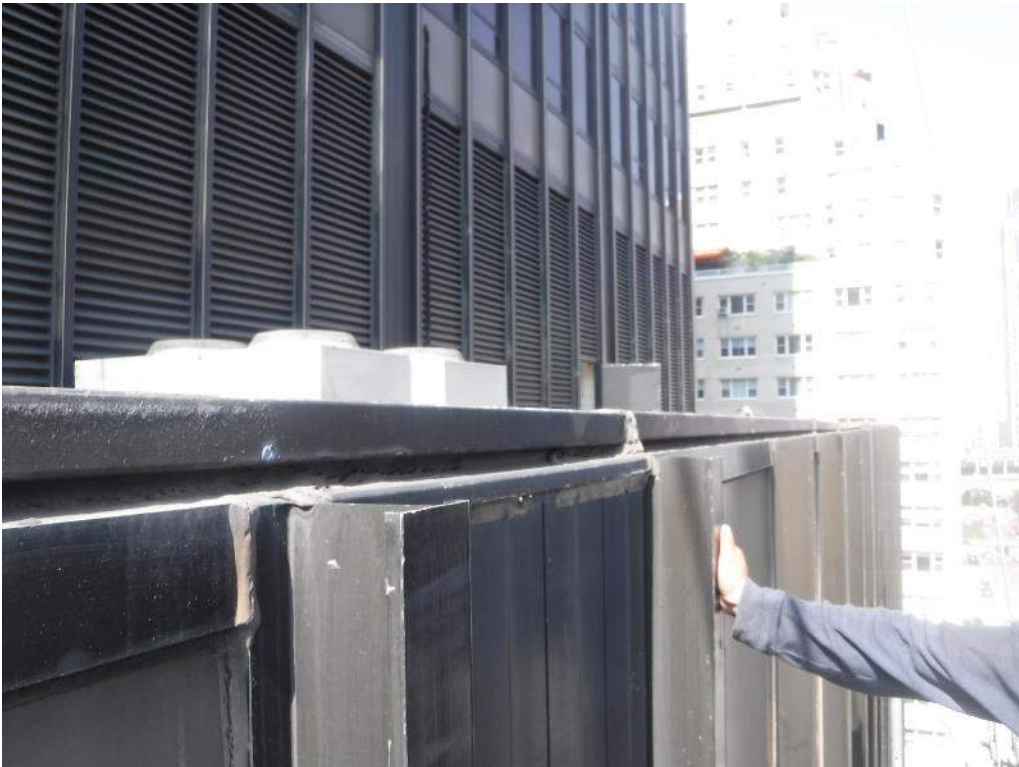
**Detail Photo No. 4** – Overall view of East Elevation parapet exterior at 8<sup>th</sup> Floor setback roof.

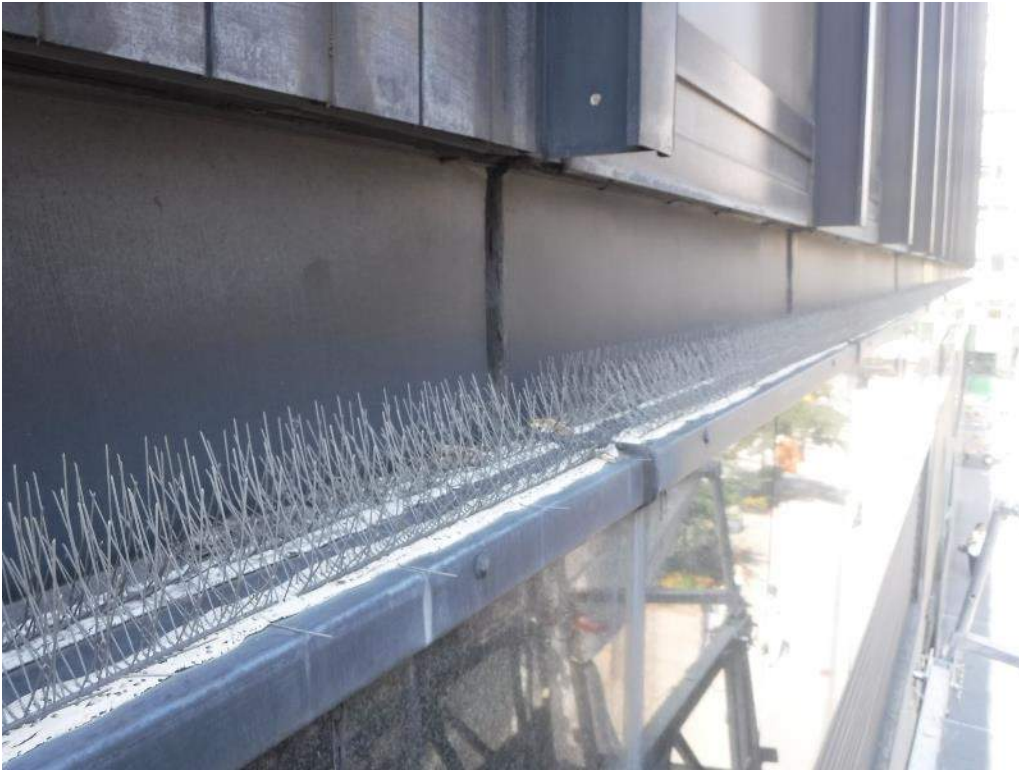
**Detail Photo No. 5** - Overall view of East Elevation transition from curtain wall to granite clad wall.

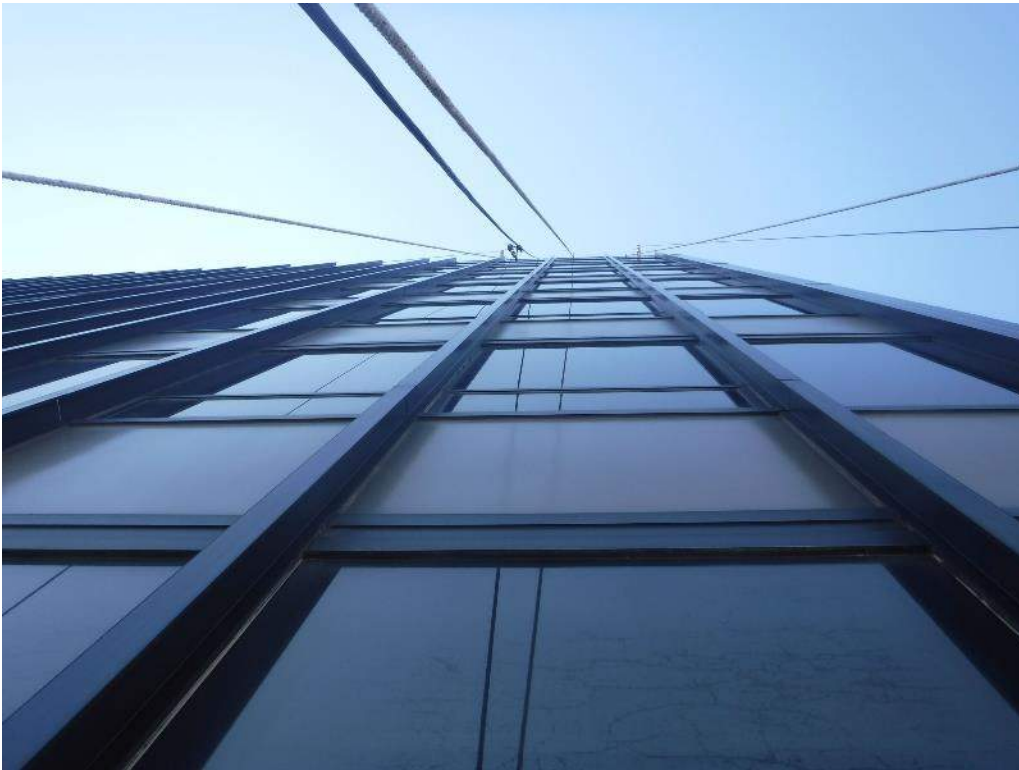
**Detail Photo No. 6** – Overall view of North Elevation curtain wall detailing.

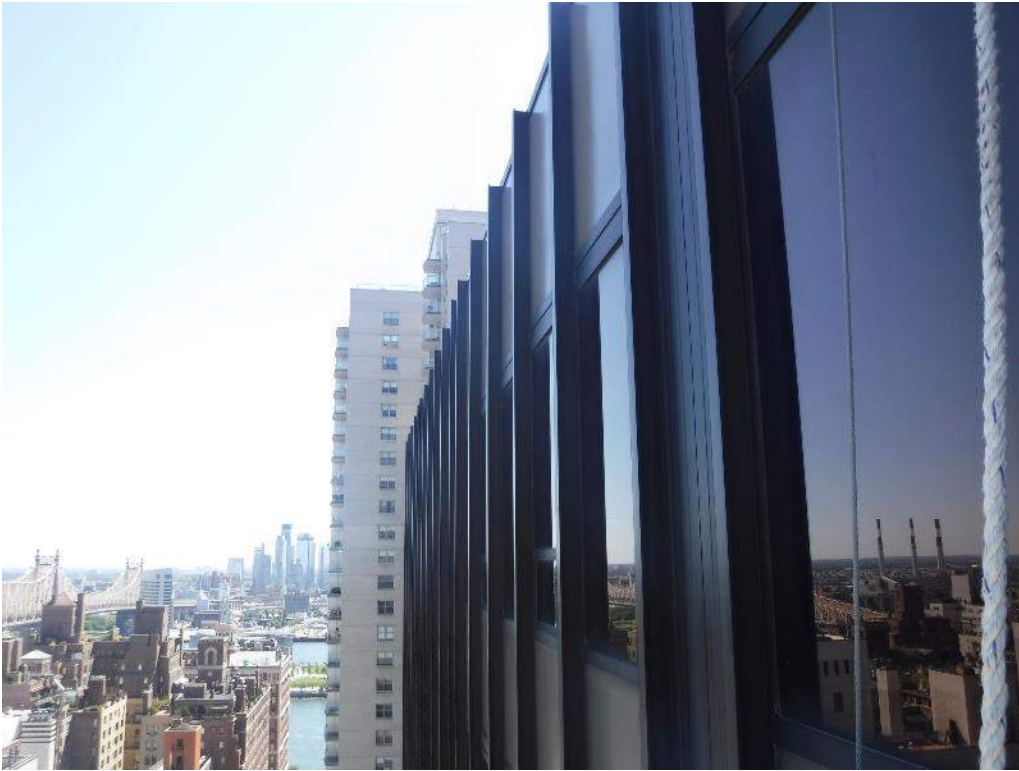
**Detail Photo No. 7** - Overall view of North Elevation parapet exterior at top of building.

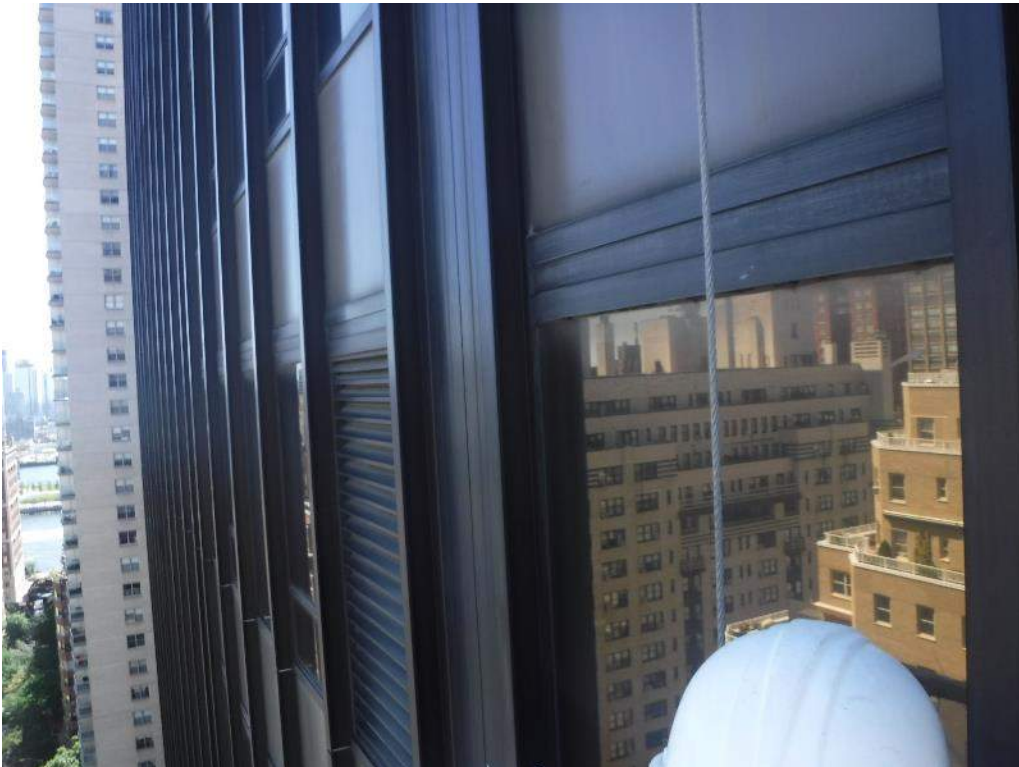
**Detail Photo No. 8** – Overall view of North Elevation curtain wall detailing.

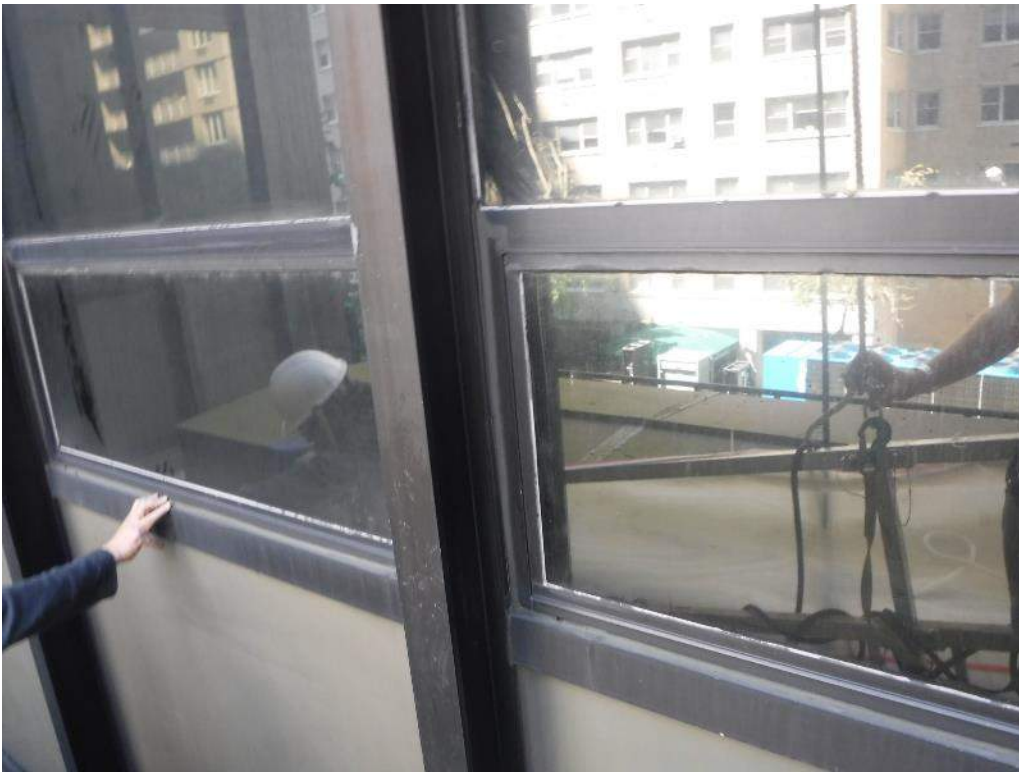
**Detail Photo No. 9** - Overall view of North Elevation curtain wall detailing.

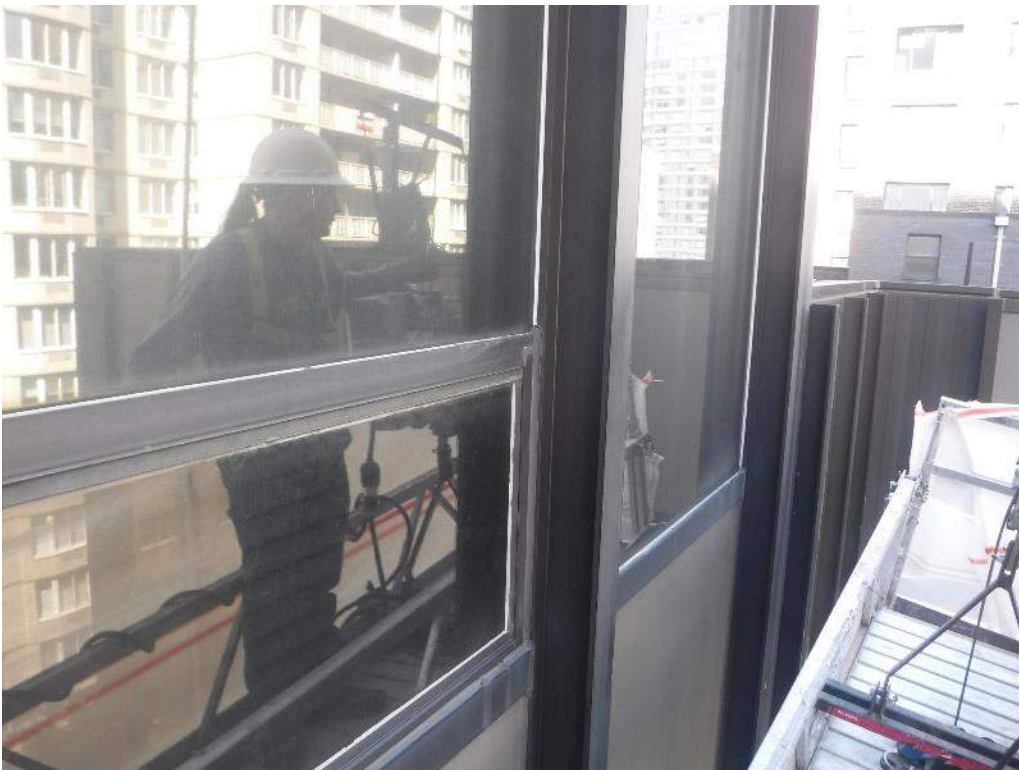
**Detail Photo No. 10** – Overall view of North Elevation curtain wall detailing.

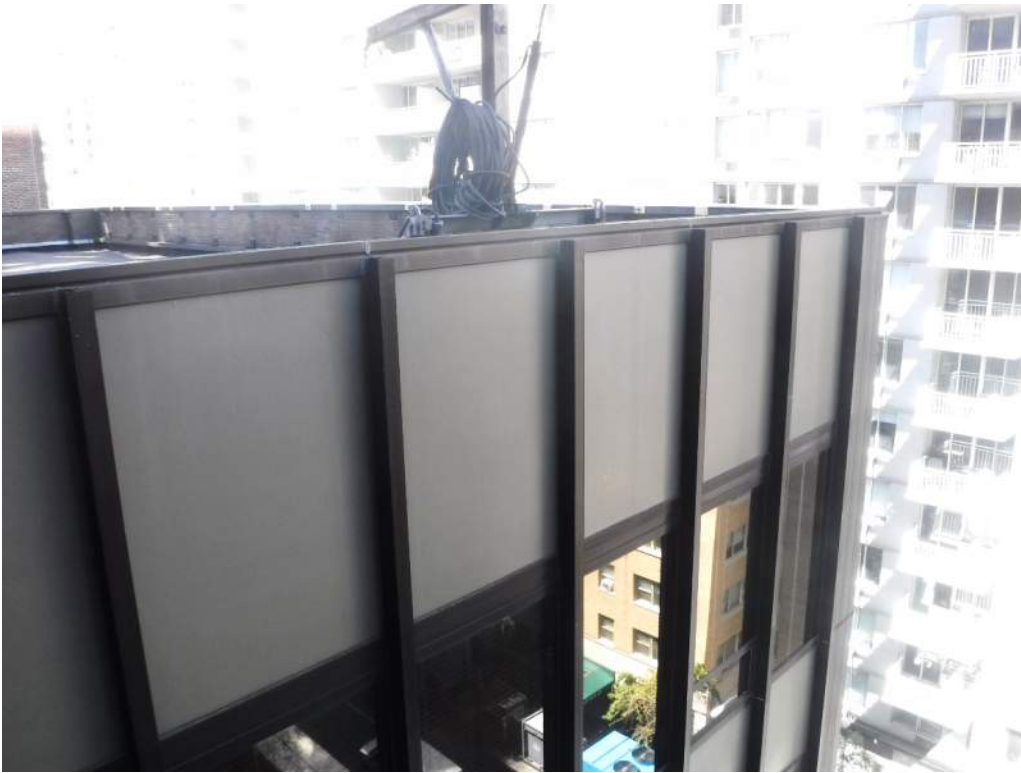
**Detail Photo No. 11** - Overall view of North Elevation parapet exterior at 7<sup>th</sup> Floor Setback Roof.

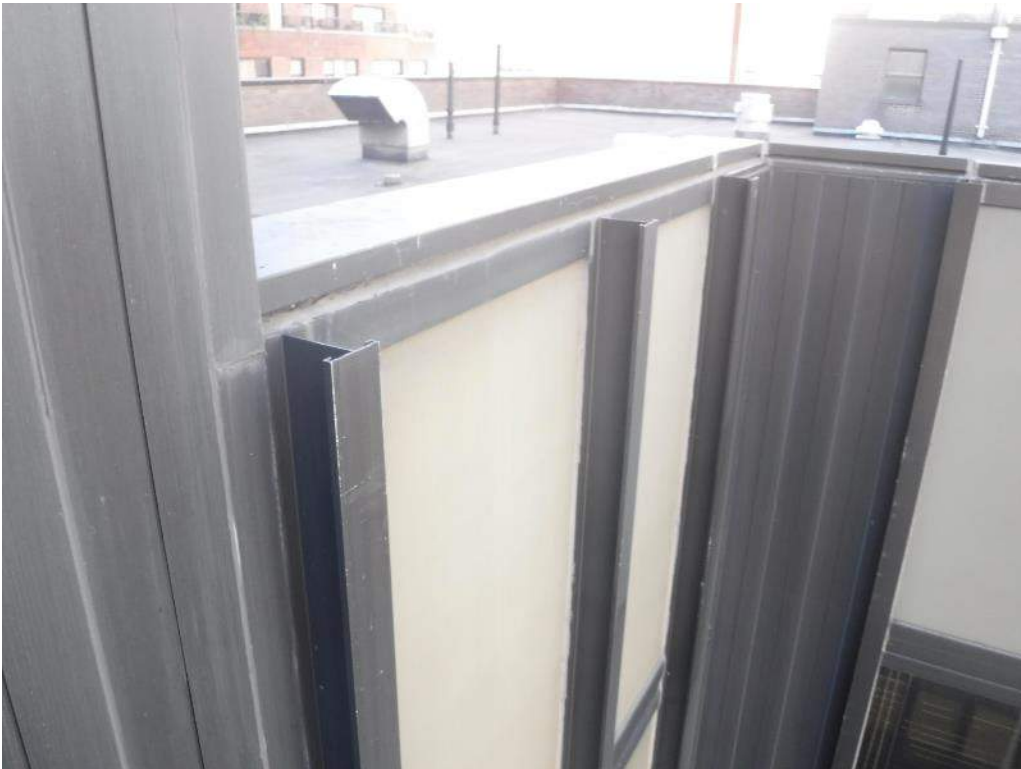
**Detail Photo No. 12** – Overall view of North Elevation parapet exterior at 7<sup>th</sup> Floor Setback Roof.

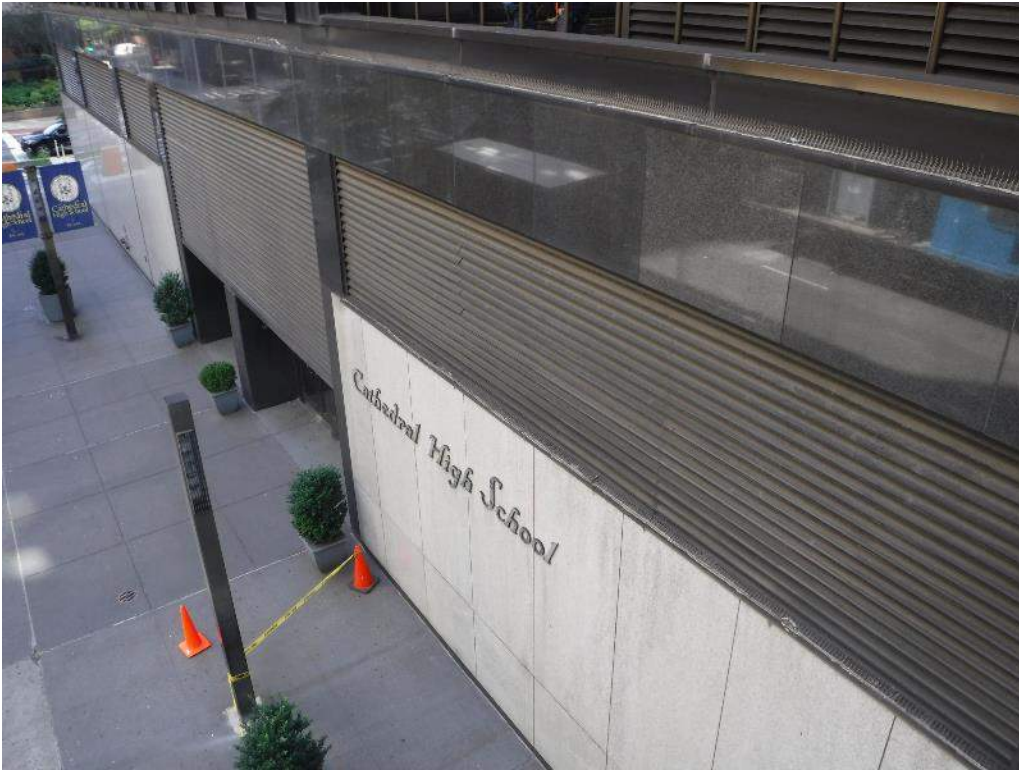
**Detail Photo No. 13** - Overall view of North Elevation, lower floors.

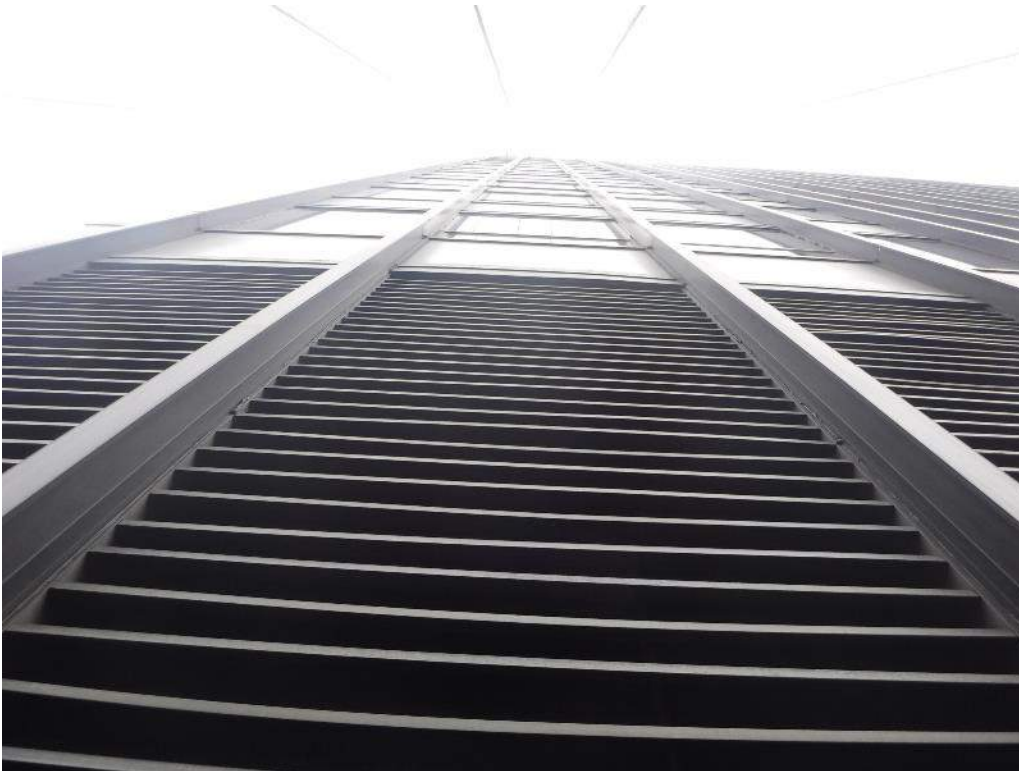
**Detail Photo No. 14** – Overall view of South Elevation.

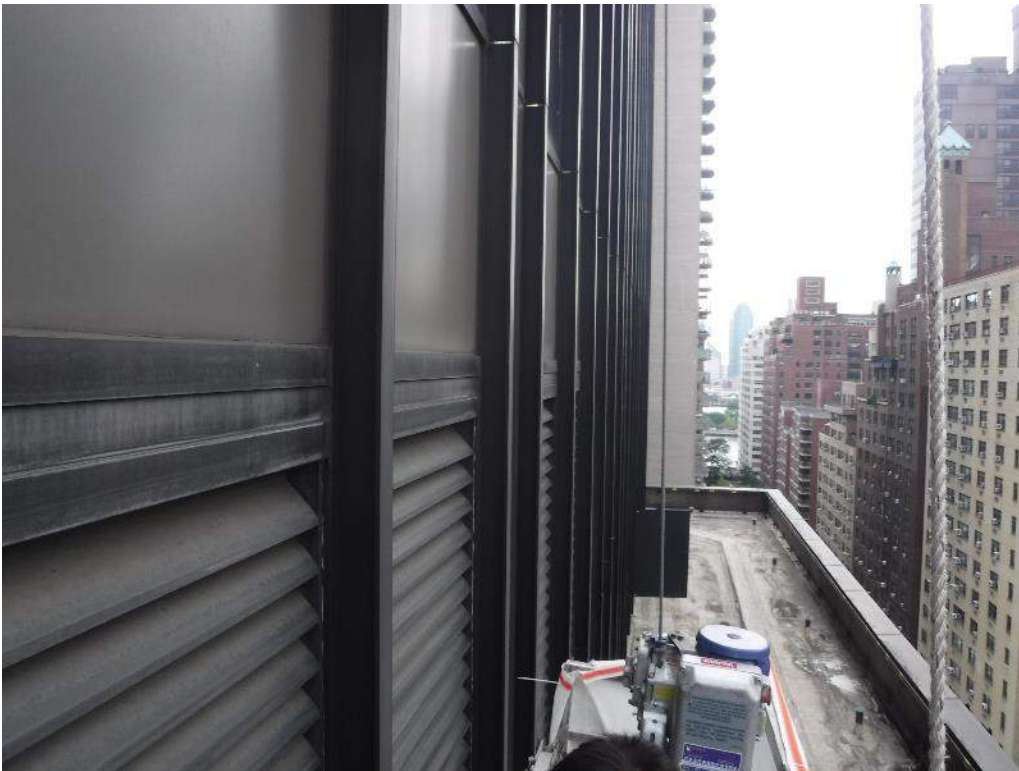
**Detail Photo No. 15** - Overall view of South Elevation, curtain wall detailing.

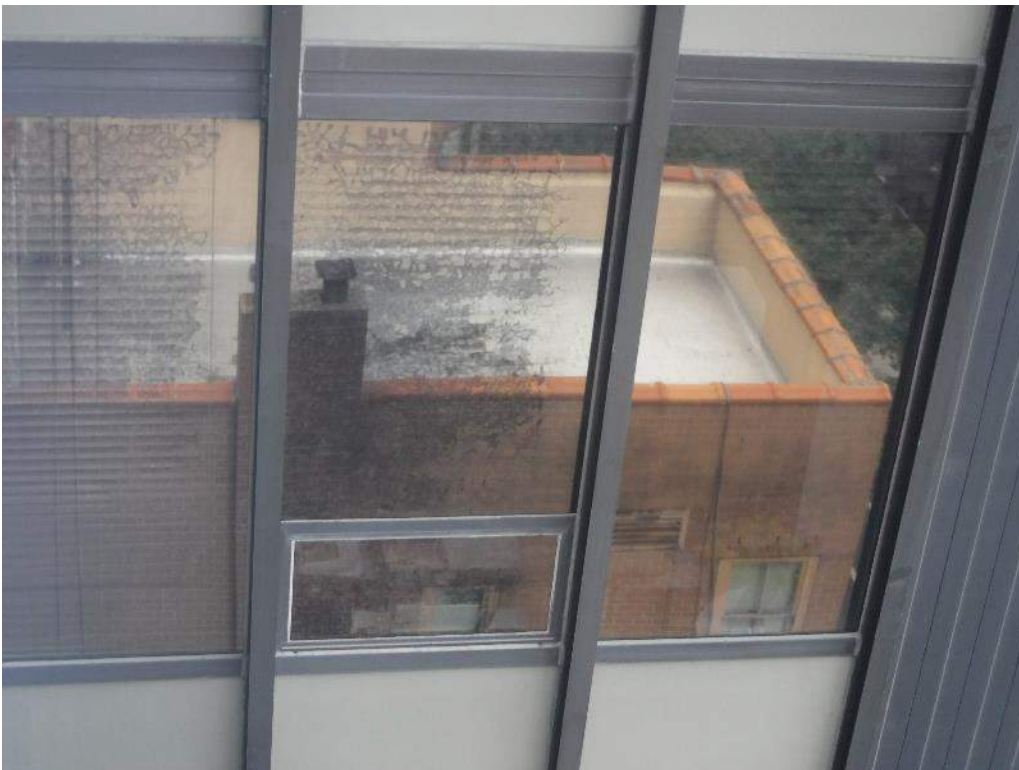
**Detail Photo No. 16** – Overall view of South Elevation, curtain wall detailing.

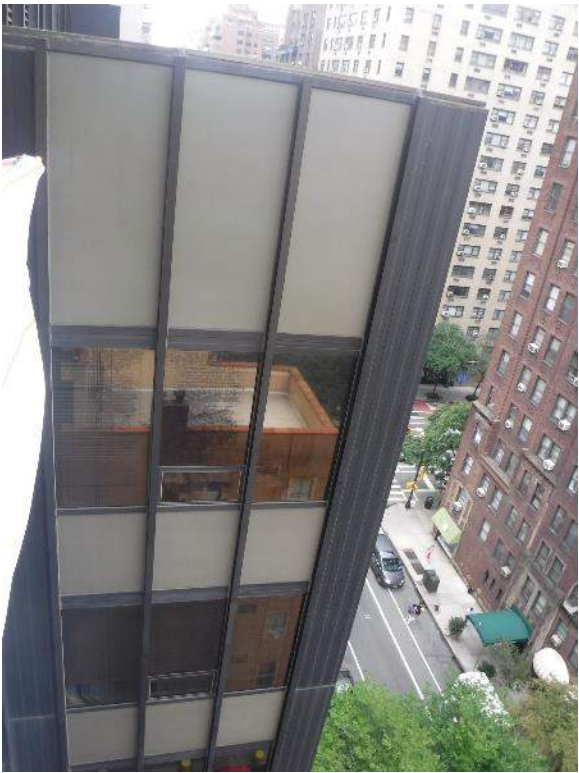
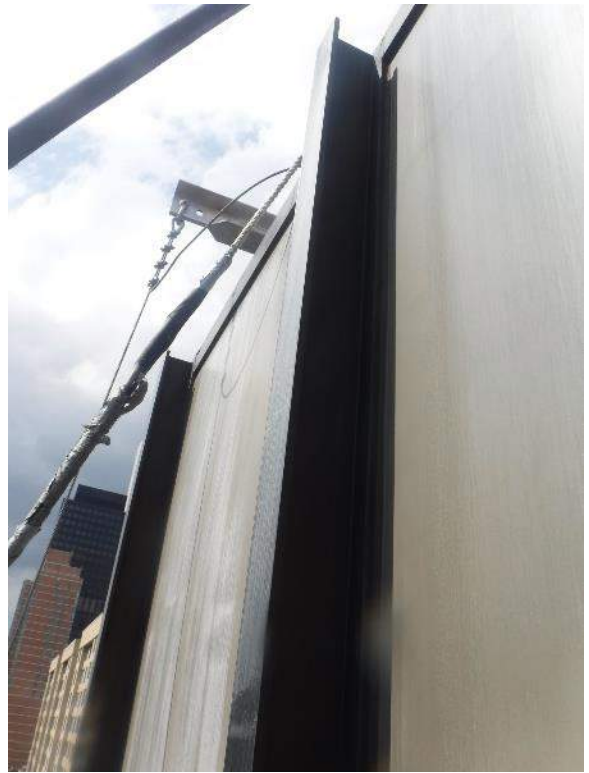
**Detail Photo Nos. 17a & b** - Overall view of South Elevation, exterior face of 8<sup>th</sup> Floor Setback roof parapet at left; Main Roof parapet at right.

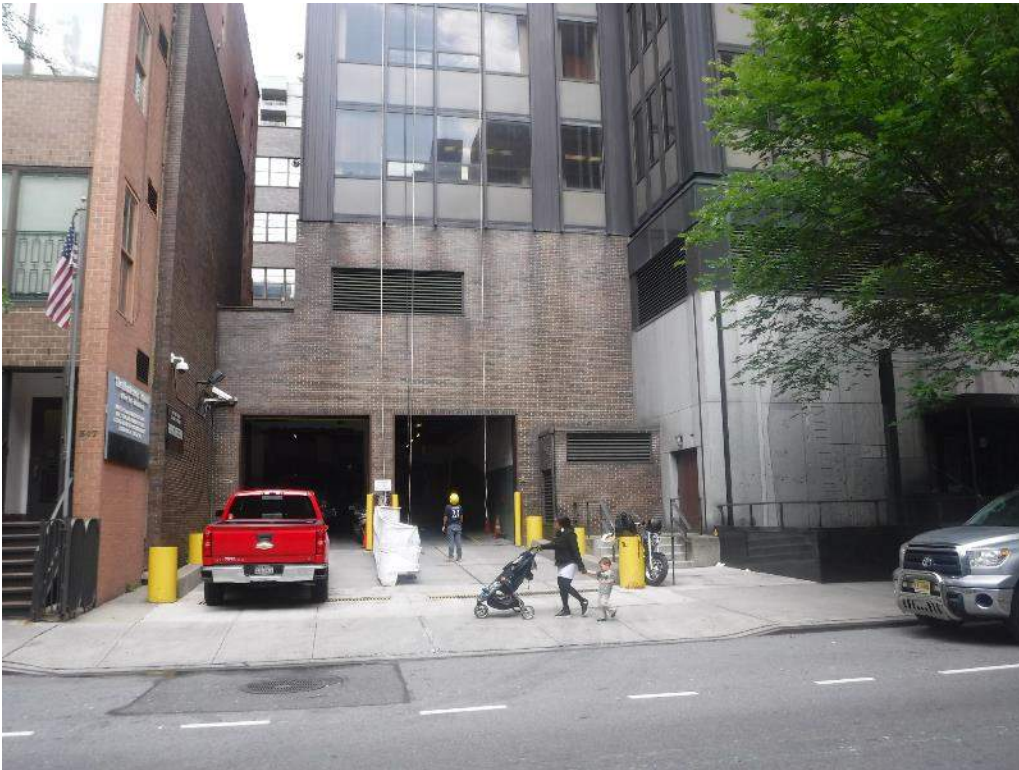
**Detail Photo No. 18** – Overall view of South Elevation, masonry façade at Loading Dock entry.

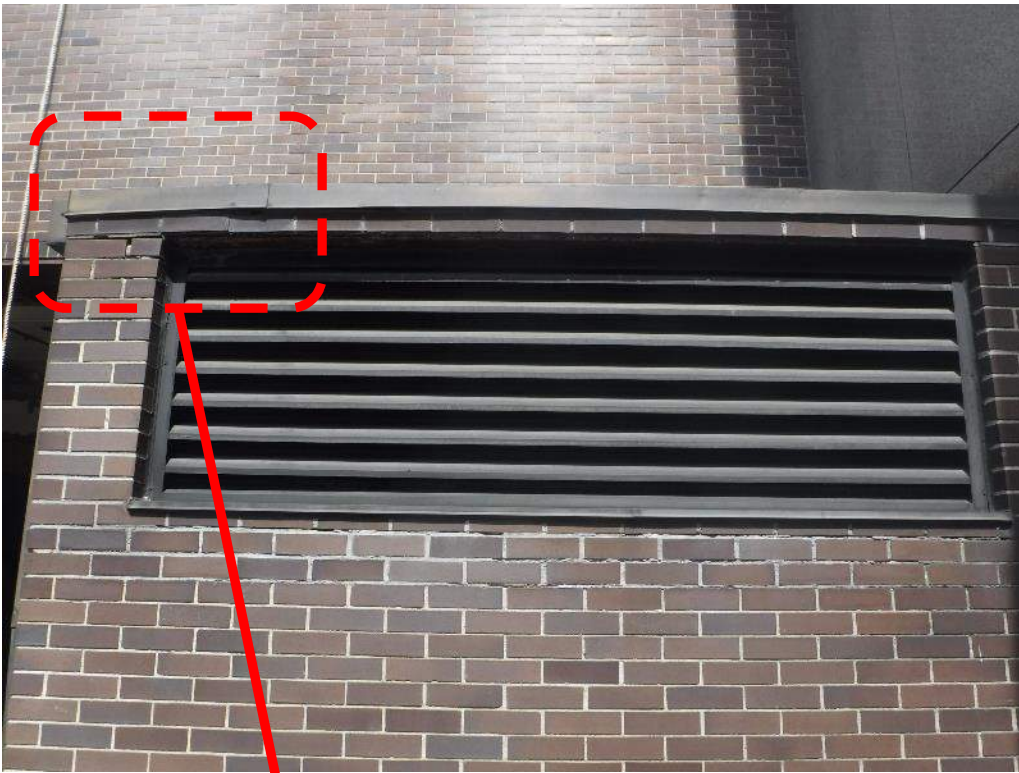
**Detail Photo No. 19** - Overall view of South Elevation, masonry façade at Loading Dock entry.

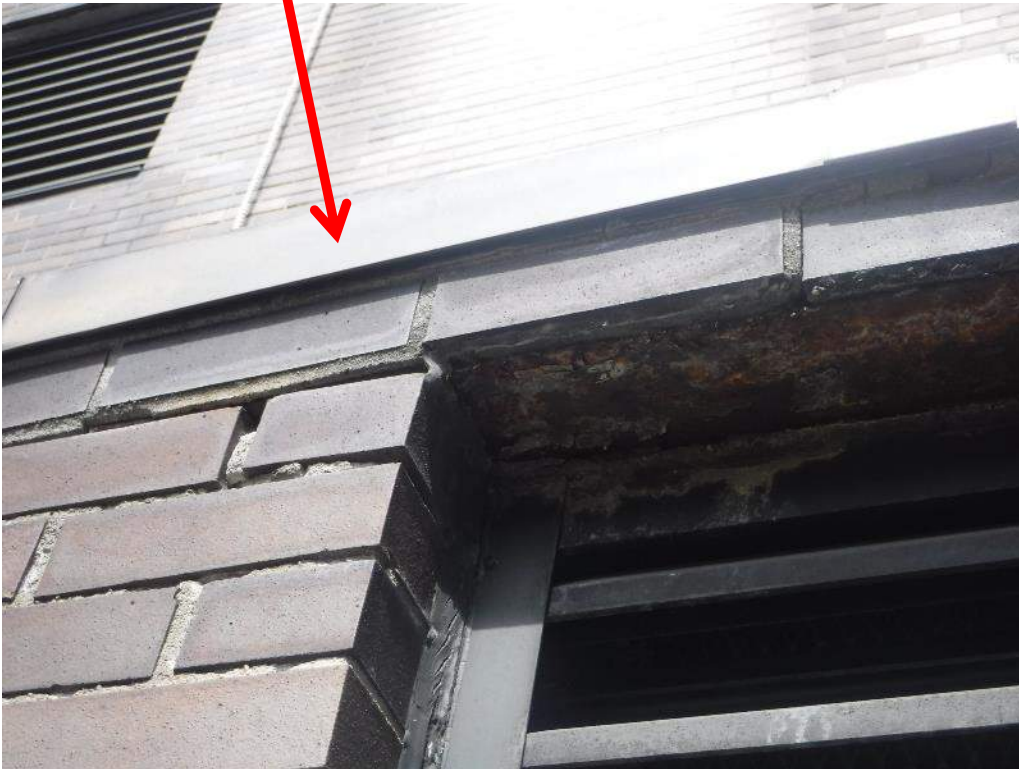
**Detail Photo No. 20** – Overall view of South Elevation, masonry façade at Loading Dock entry – note open joints.

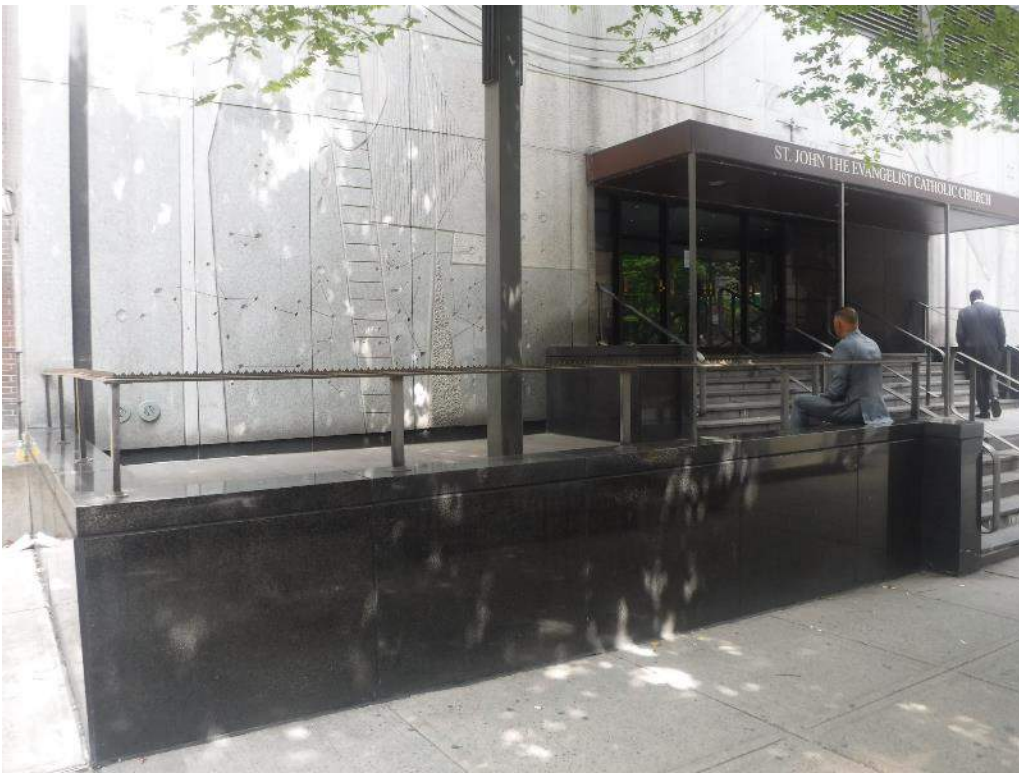
**Detail Photo No. 21 -** Overall view of South Elevation, granite façade at Church entry.

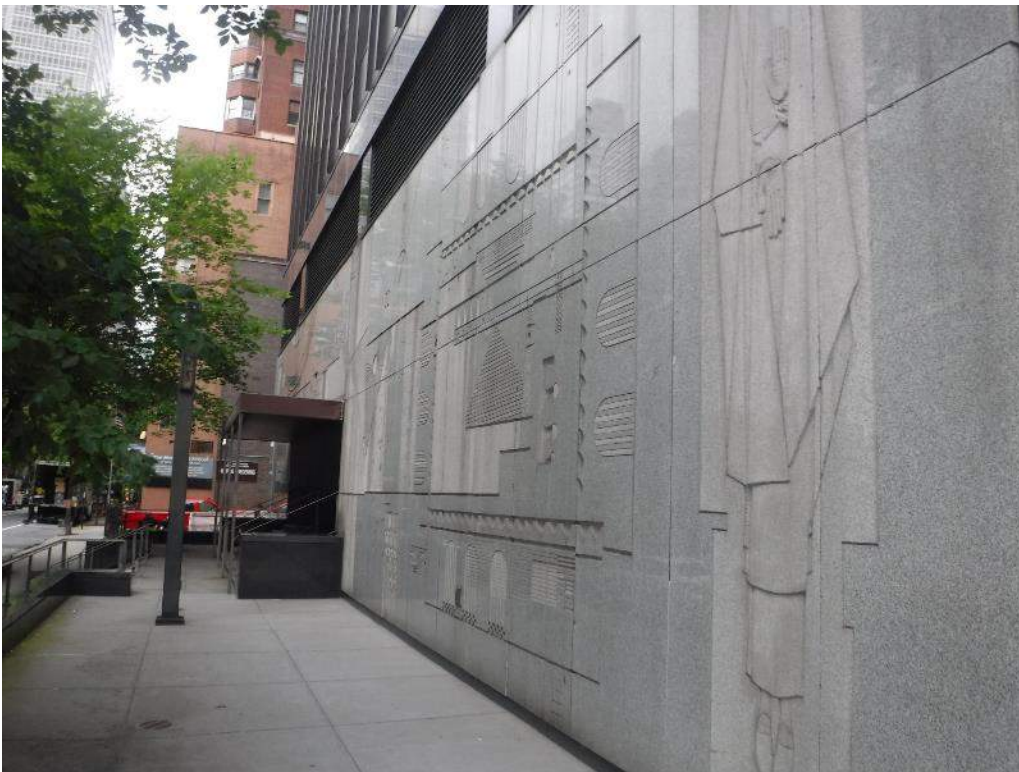
**Detail Photo No. 22 –** Overall view of South Elevation, granite façade at ground floor.

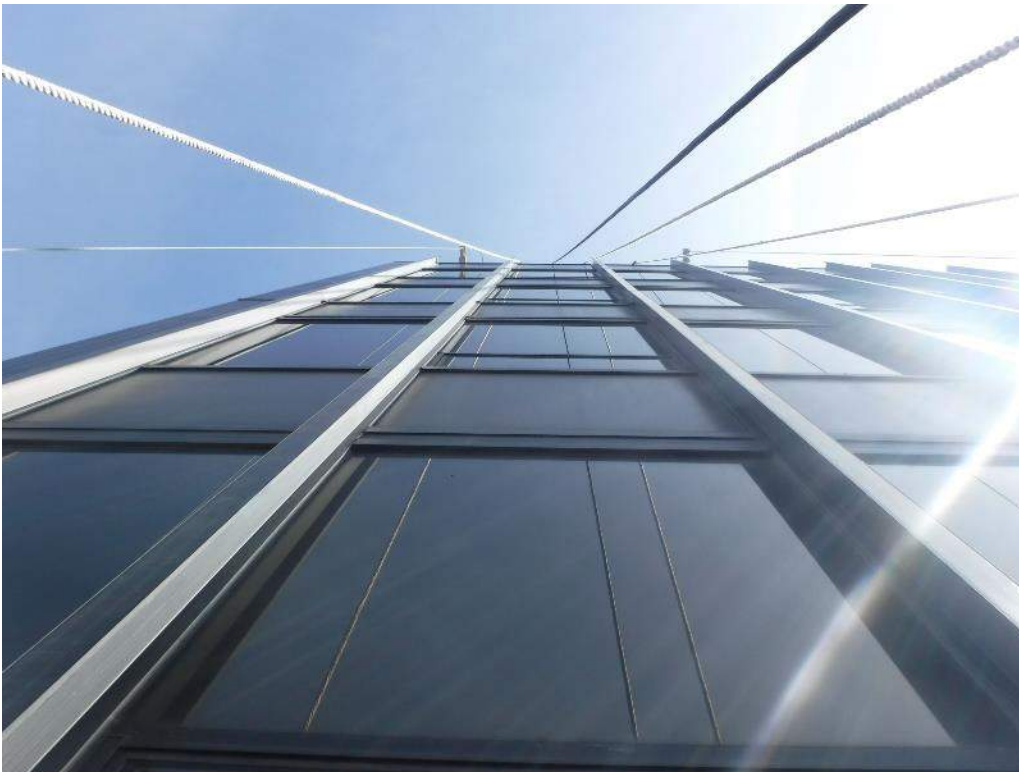
**Detail Photo No. 23 -** Overall view of West Elevation, curtain wall detailing.

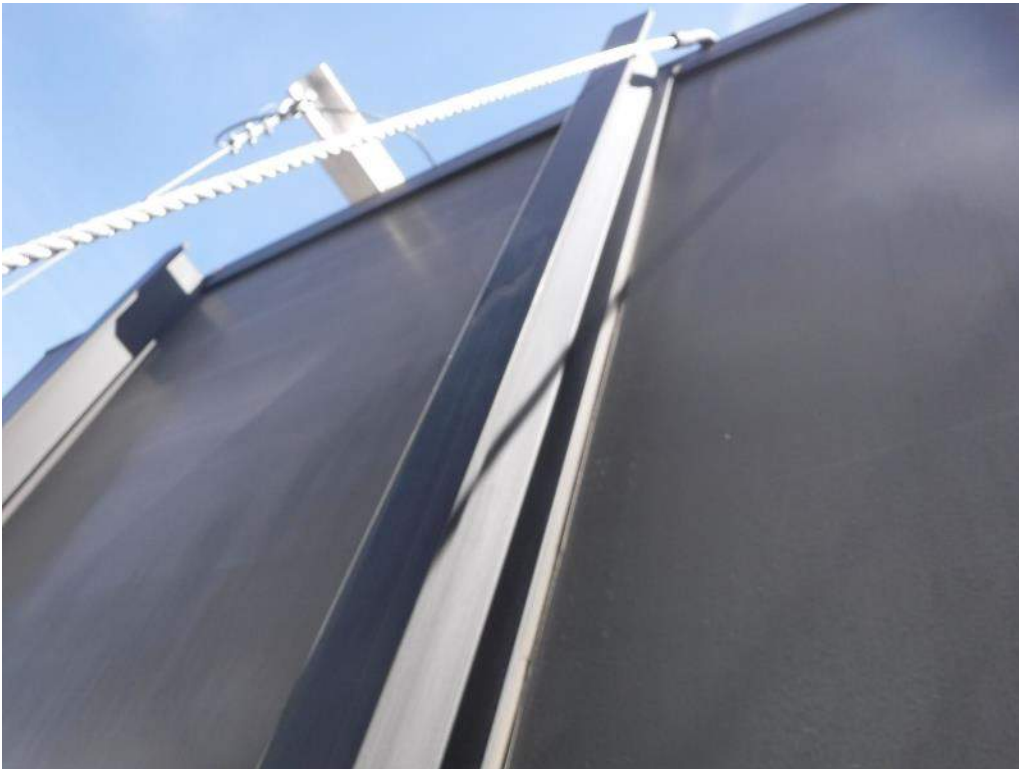
**Detail Photo No. 24 –** Overall view of West Elevation, parapet exterior at top of building.

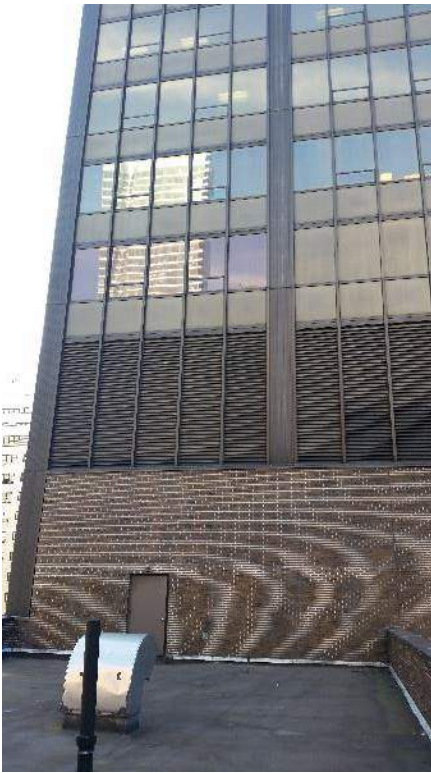
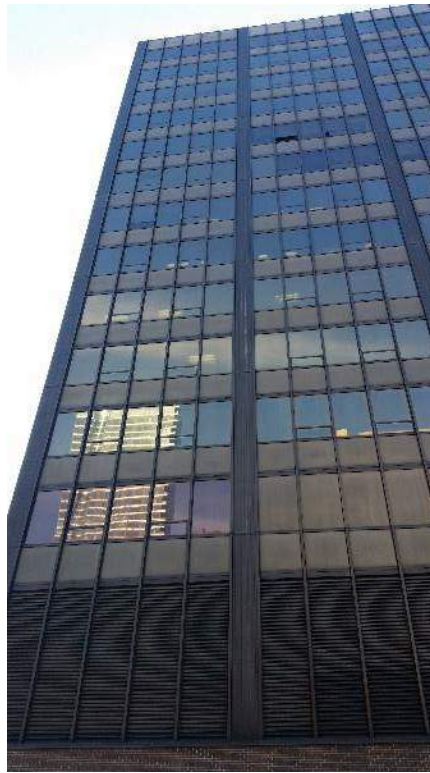
**Detail Photo Nos. 25a & b - Overall view of West Elevation.**

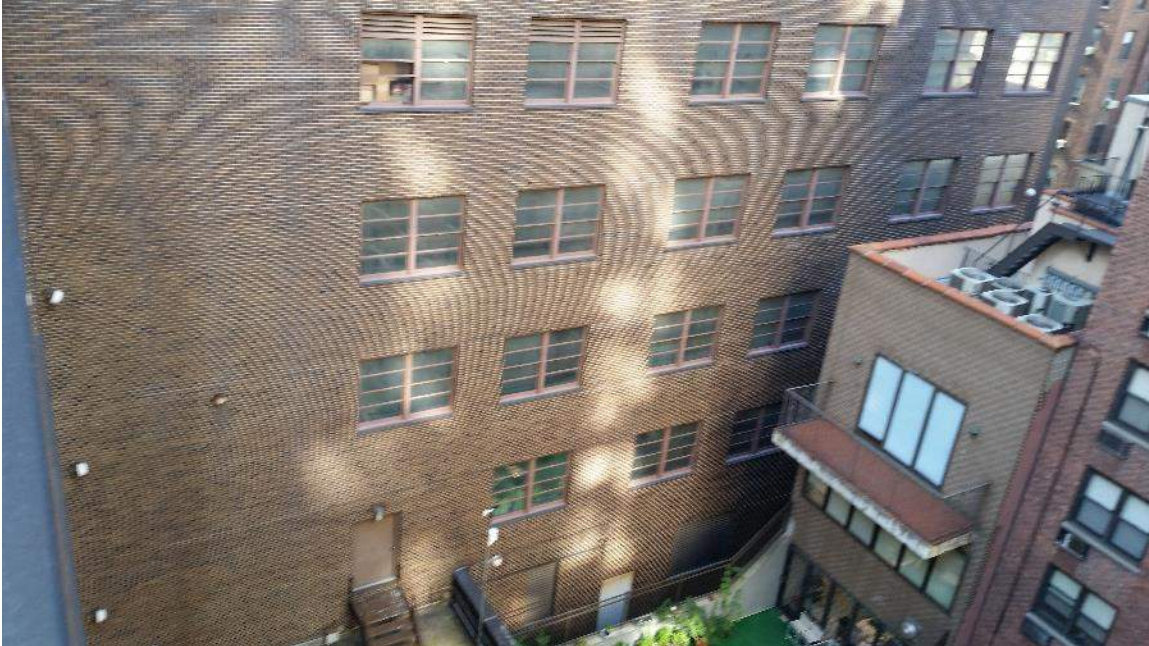
**Detail Photo No. 26 – Overall view of West Elevation, lower floors.**

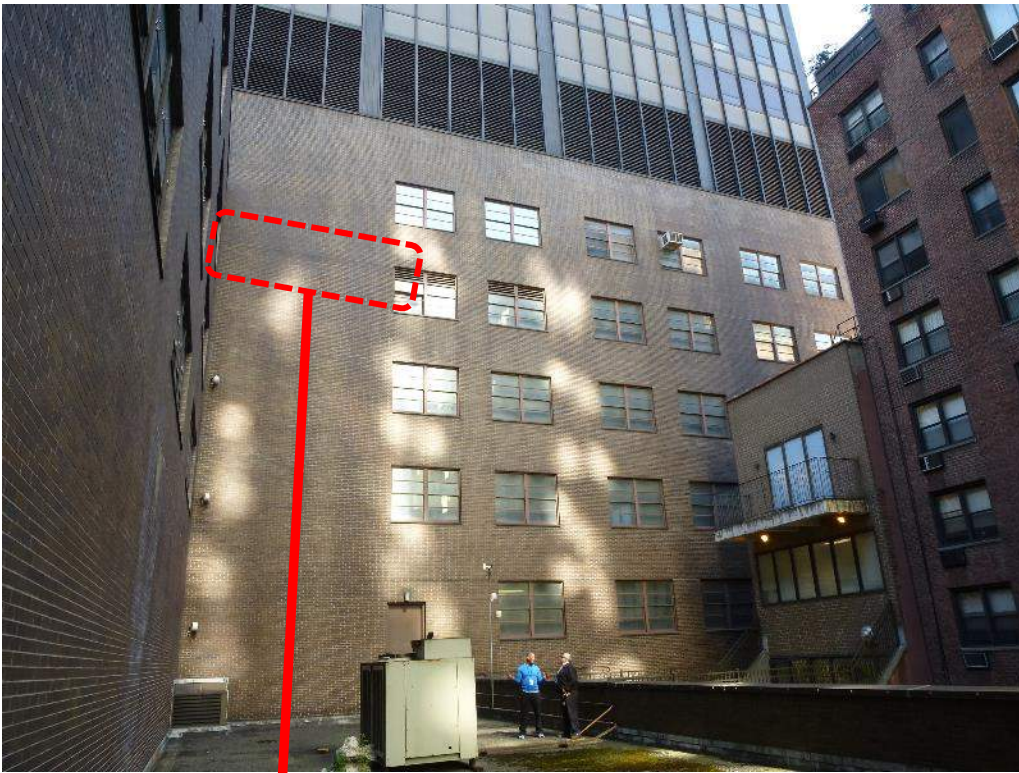
**Detail Photo No. 27 -** Overall view of West Elevation, lower floors, masonry facade.

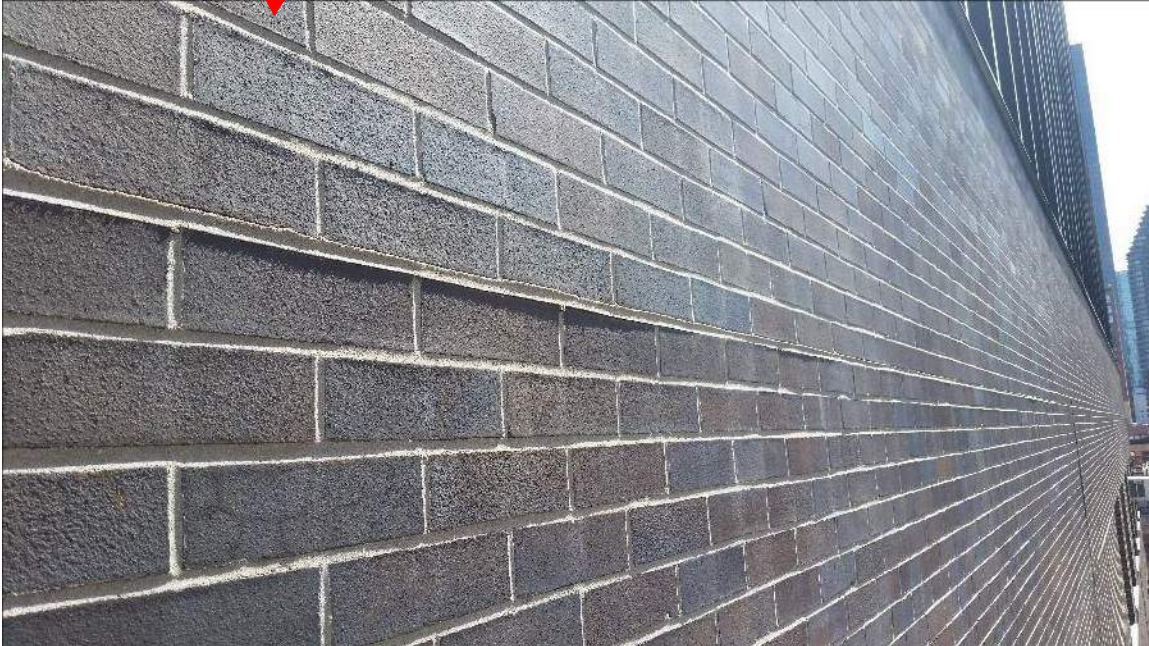
**Detail Photo No. 28 –** Detail view of West Elevation, loose mortar joint.

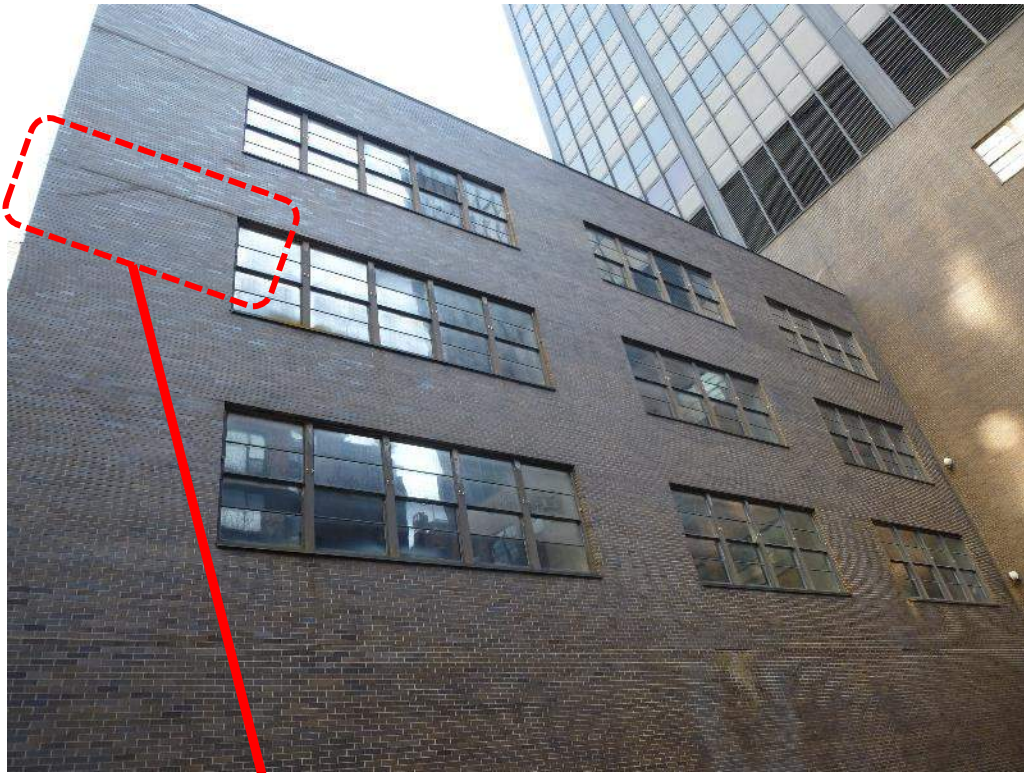
**Detail Photo No. 29** - Overall view of South Recessed Elevation, masonry facade.
