PROJECT  
**1005 1<sup>st</sup> Avenue, New York, NY**  
**Cycle 8 FISP Inspection**

DATE  
**September 15, 2017**

TITLE  
**Detail Photos**

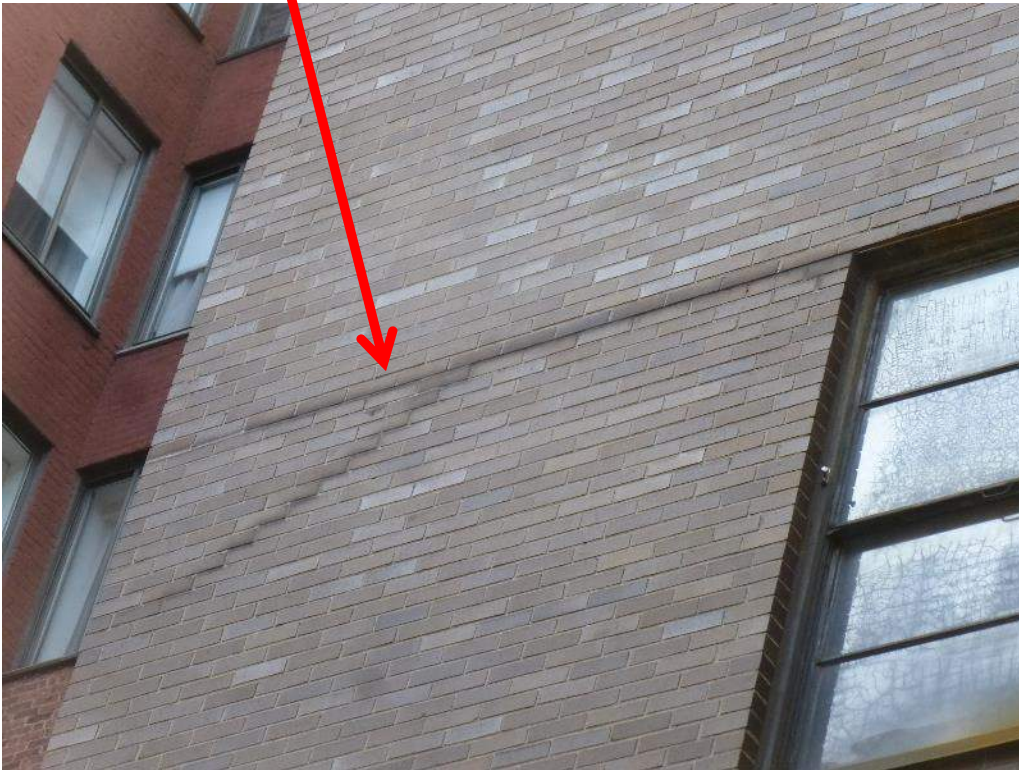
**Detail Photo No. 30** – Detail view of cracked brick and loose mortar joints.

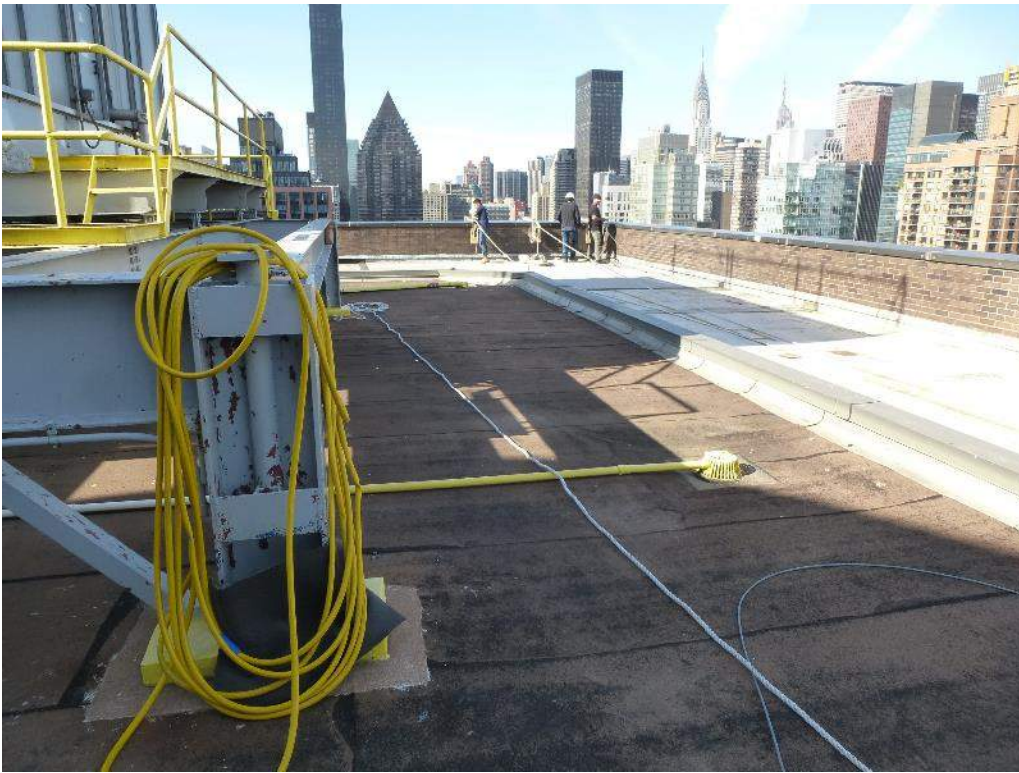
**Detail Photo No. 33** – Main Roof looking north.

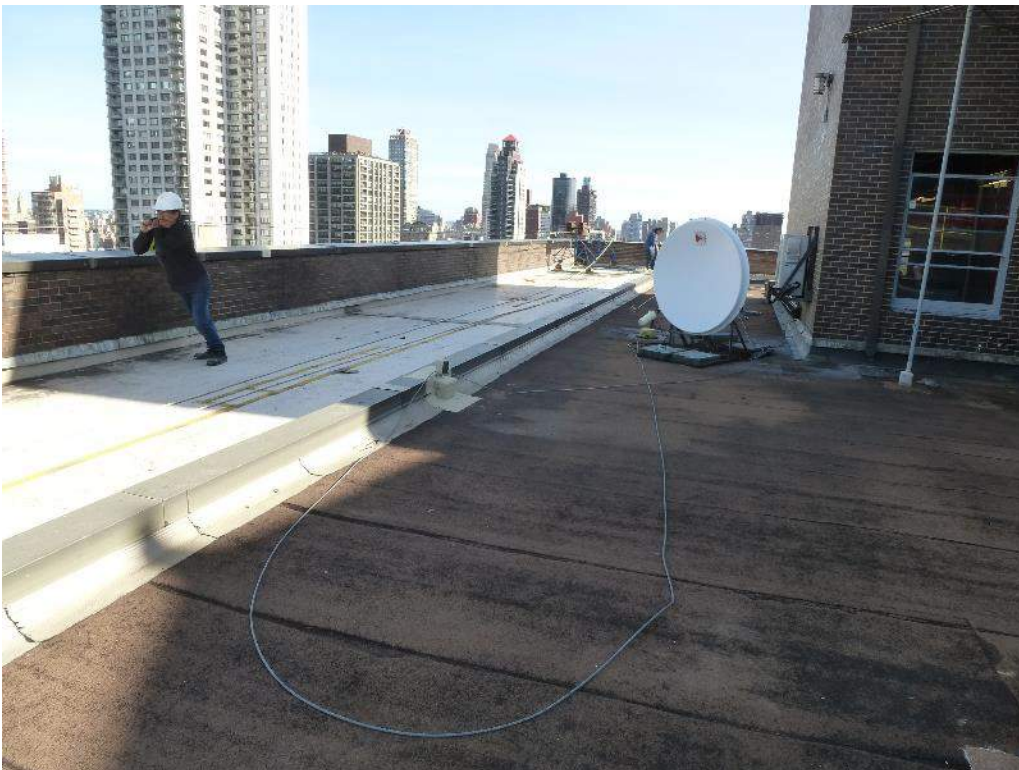
**Detail Photo No. 34** – Main Roof looking south.

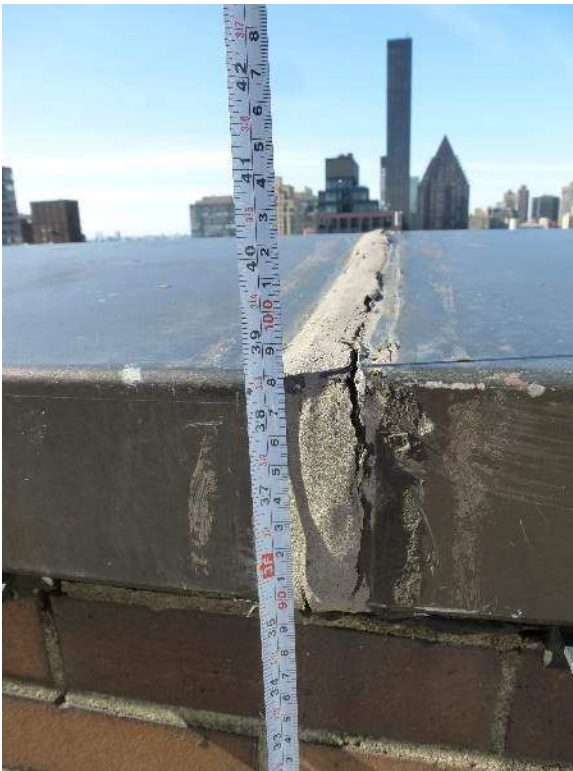
**Detail Photo No. 33** – Main Roof – parapet height at 38½”.

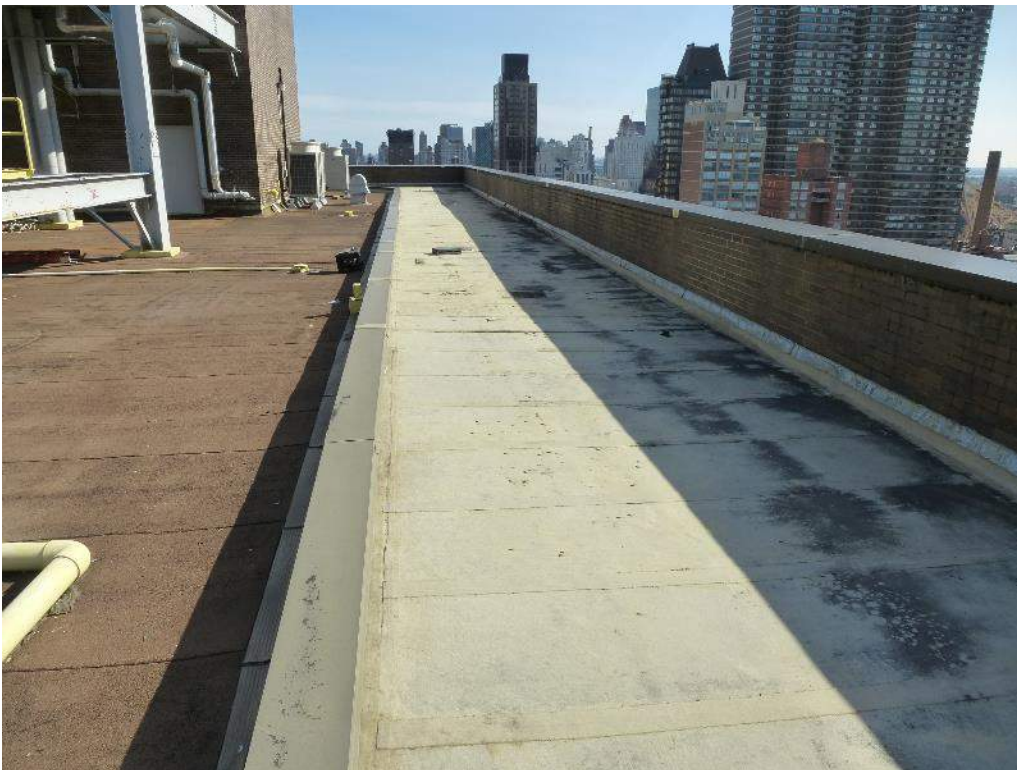
**Detail Photo No. 34** – Main Roof looking south at window washing track.

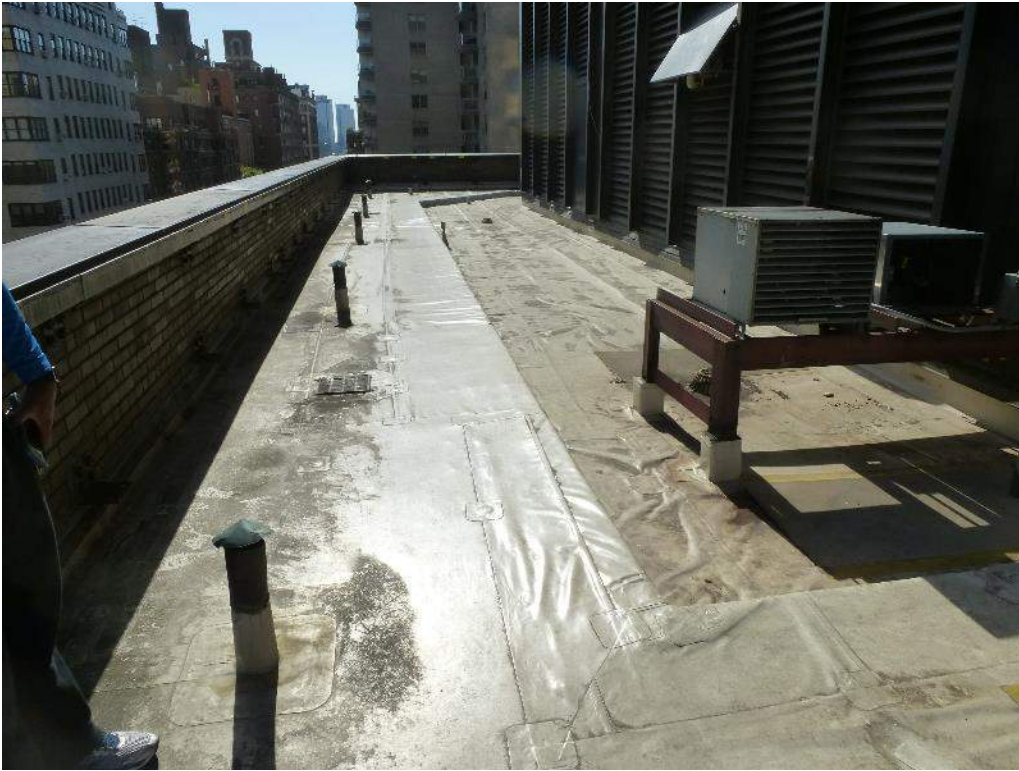
**Detail Photo No. 35** – 8<sup>th</sup> Floor Setback Roof looking east.

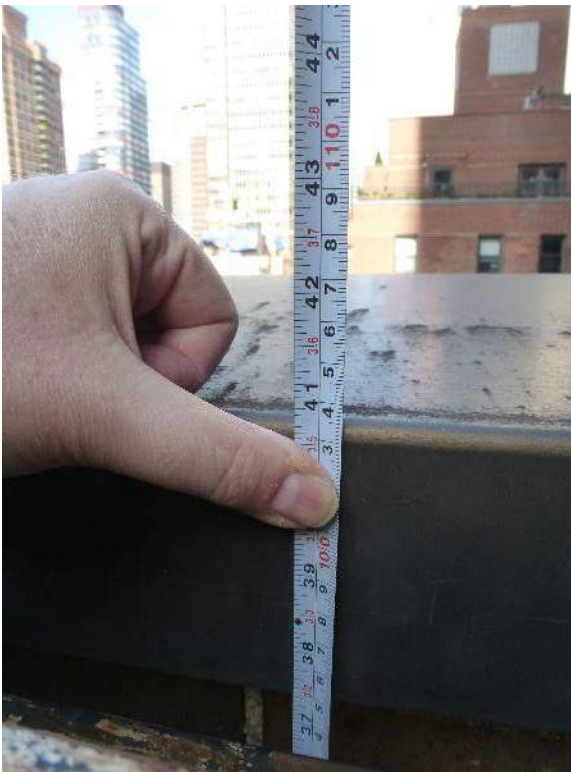
**Detail Photo No. 36** – 8<sup>th</sup> Floor Setback Roof - parapet height at 41".

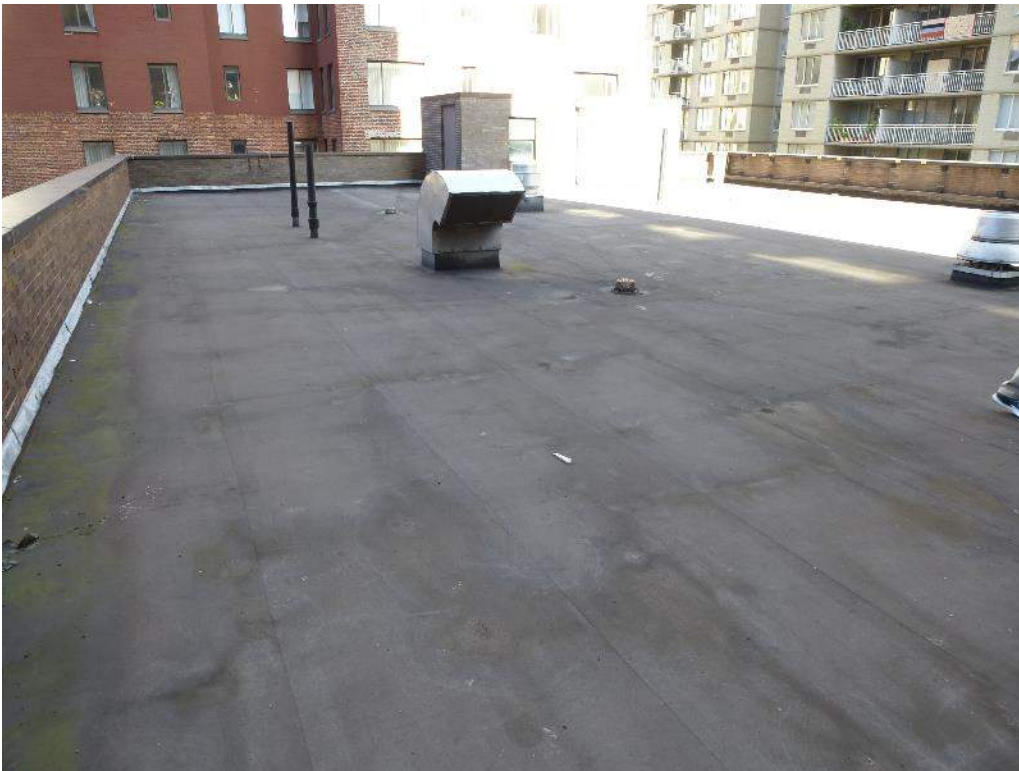
**Detail Photo No. 37** – 7<sup>th</sup> Floor Setback Roof looking west.

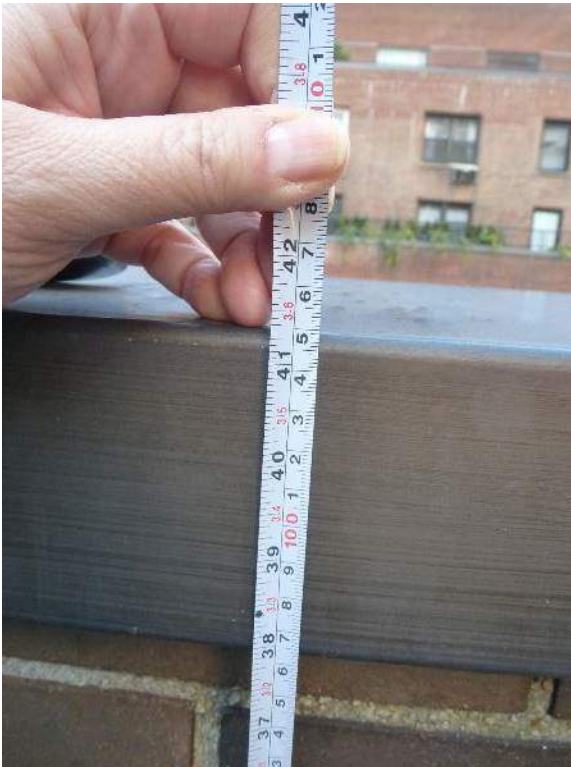
**Detail Photo No. 38** – 7<sup>th</sup> Floor Setback Roof - parapet height at 41½”.

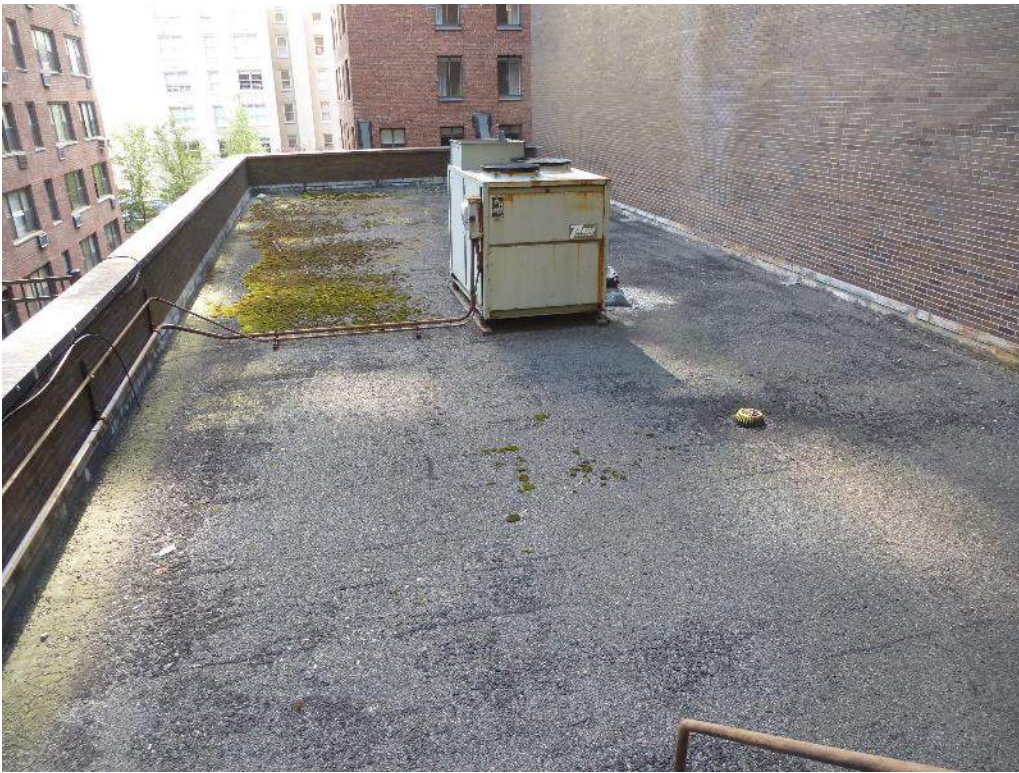
**Detail Photo No. 39** – 3<sup>rd</sup> Floor Setback Roof looking west.

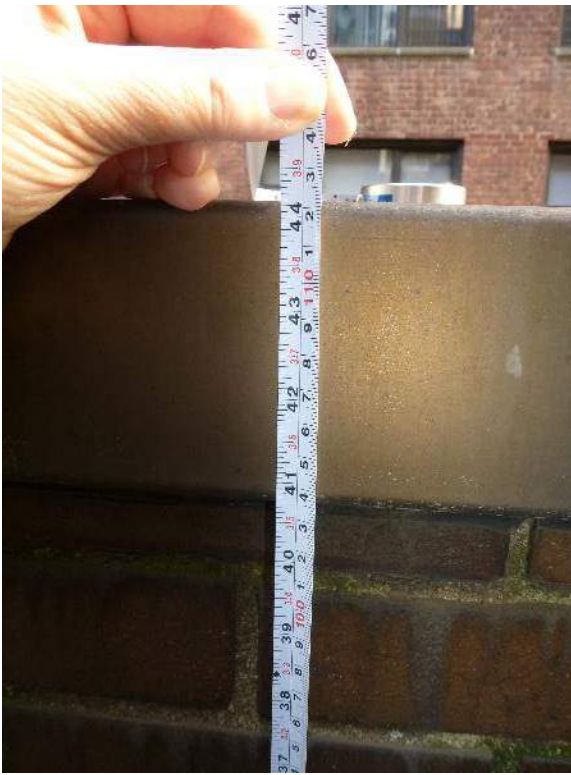
**Detail Photo No. 40** – 3<sup>rd</sup> Floor Setback Roof - parapet height at 44".

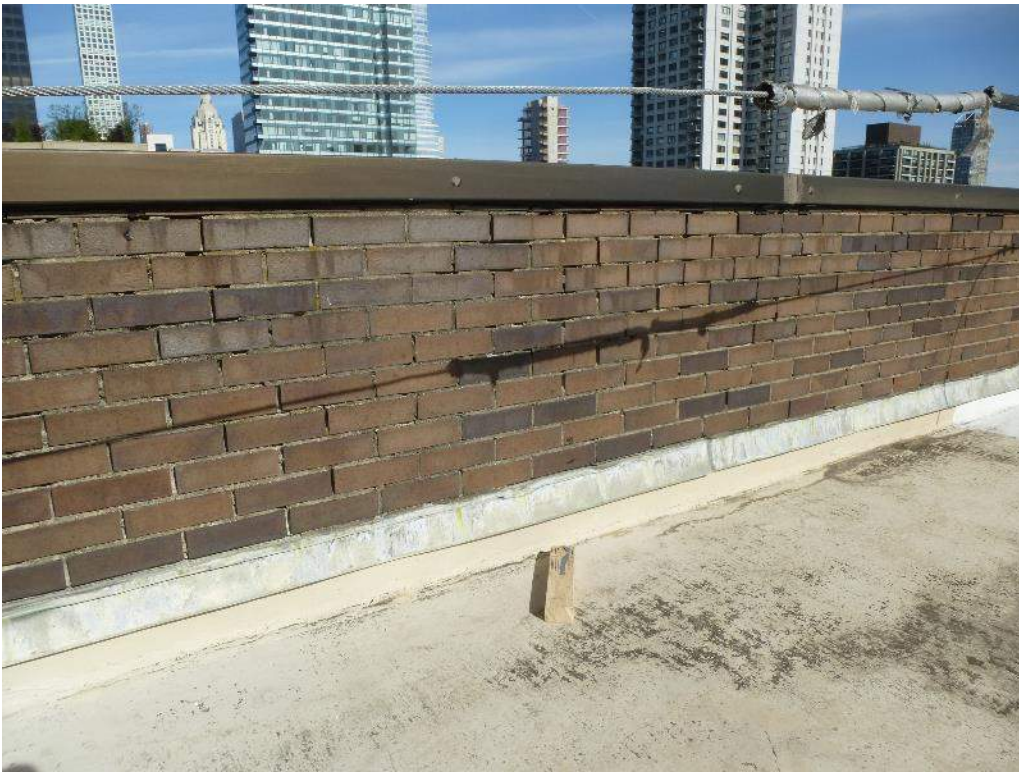
**Detail Photo No. 41** – Main Roof parapet – deteriorated mortar joints.

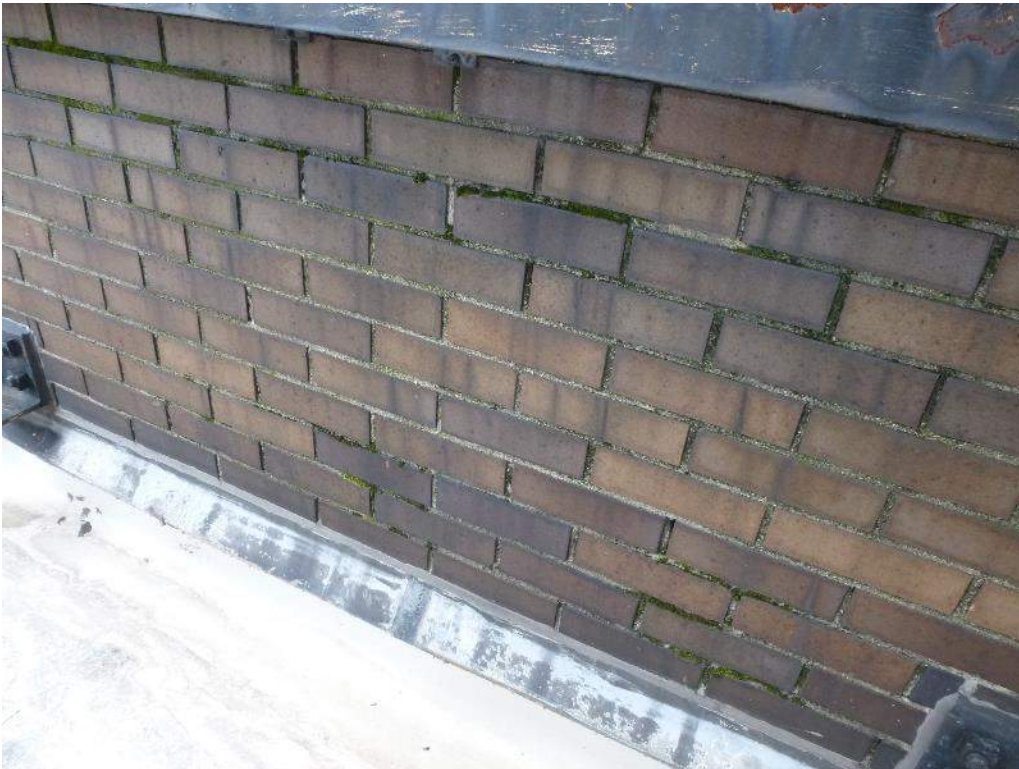
**Detail Photo No. 42** – 8<sup>th</sup> Floor Setback Roof parapet – deteriorated mortar joints..
