# ENGINEER'S REPORT

**ADDRESS: 352 EAST 55<sup>TH</sup> STREET**  
**PREPARED FOR: YING TONG REALTY LLC**  
**DATE: FEBRUARY 25, 2013**

**DANIEL HOM, P. E.**  
**80 ELIZABETH ST., #7B**  
**NEW YORK, NY 10013**  
**(718) 836-8882**

Re: Premises Inspection  
352 East 55<sup>th</sup> Street  
Manhattan, NY

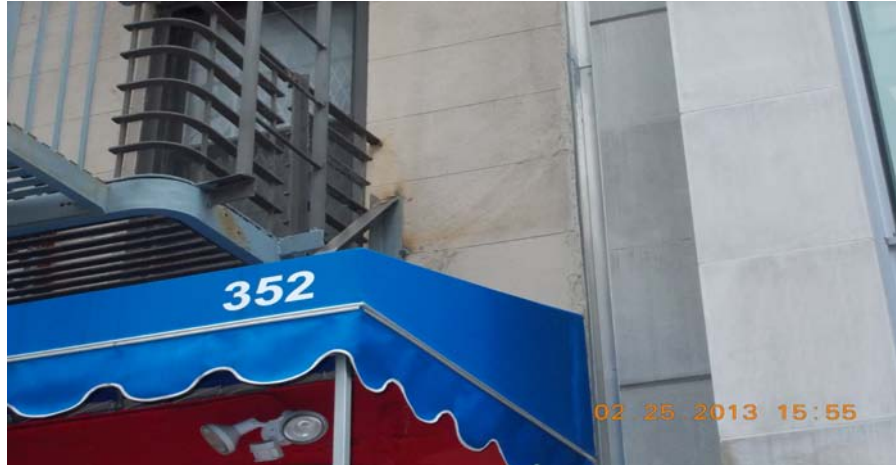
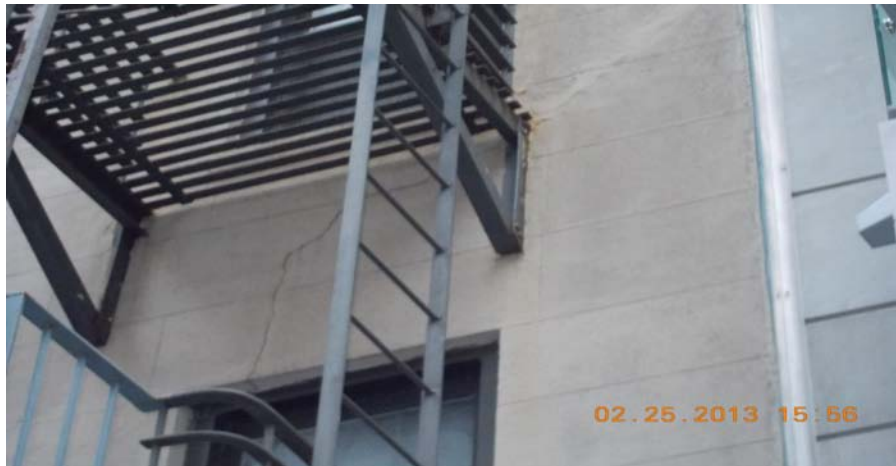
SETTLEMENT CRACKS ON FRONT EXTERIOR WALL

The front exterior wall was noted for settlement cracks especially above and below the 2<sup>nd</sup> and 3<sup>rd</sup> floor windows. See pictures. These settlement cracks are results inferior installation along with past differential settlement but of no structural concerns. However, the open cracks and deficient areas should be completely repaired and sealed with crack sealer.

The front exterior wall appeared to be coated with a thin layer of cement overlay and overall satisfactory. However, some settlement cracks were noted on the front exterior wall as mentioned earlier. See pictures. These cracks were due to previous differential settlement and not of any structural concern. However, these cracks should be completely and neatly repaired and sealed with crack sealer.

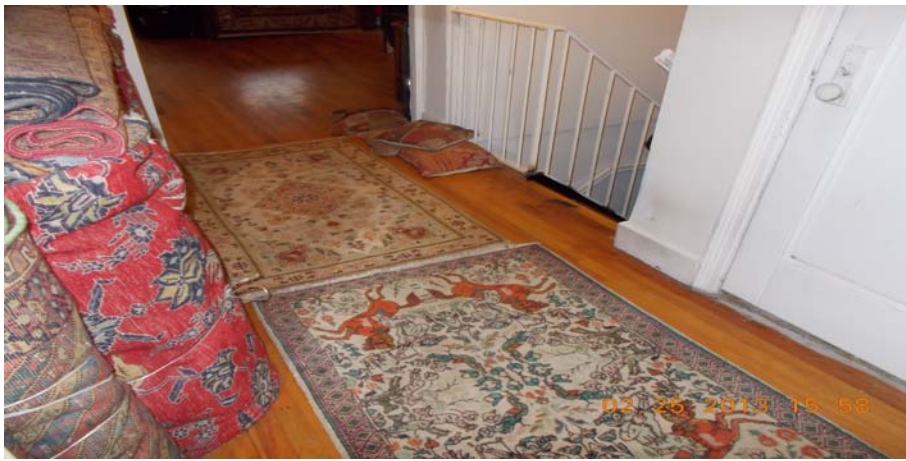
1<sup>ST</sup> FLOOR HALLWAY IN FRONT OF STAIR – NOTICEABLY SAGGING

The 1<sup>st</sup>, 2<sup>nd</sup>, 3<sup>rd</sup> and 4<sup>th</sup> floor flooring were noticeably settled especially along the apartment hallways and bathrooms are noticeably settled due to distortion/water damages to the wooden floor joists that support these areas. See pictures. The proper way to repair these areas is to remove the bathroom/hallway floorings in order to secure/replace and reinforce the wooden joists.

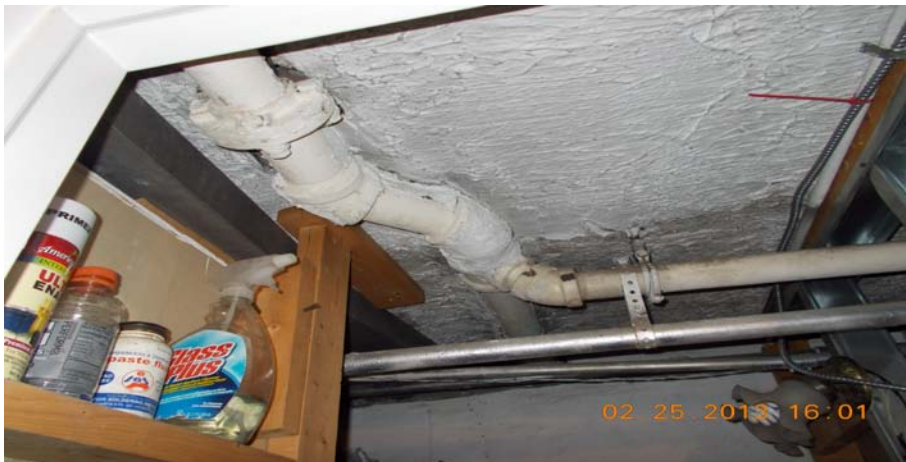
BASEMENT - ASBESTOS ON HEATING PIPES

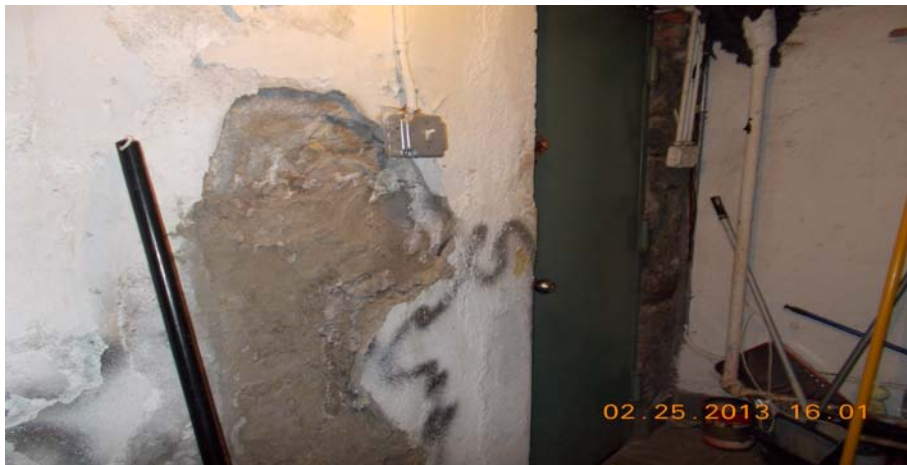
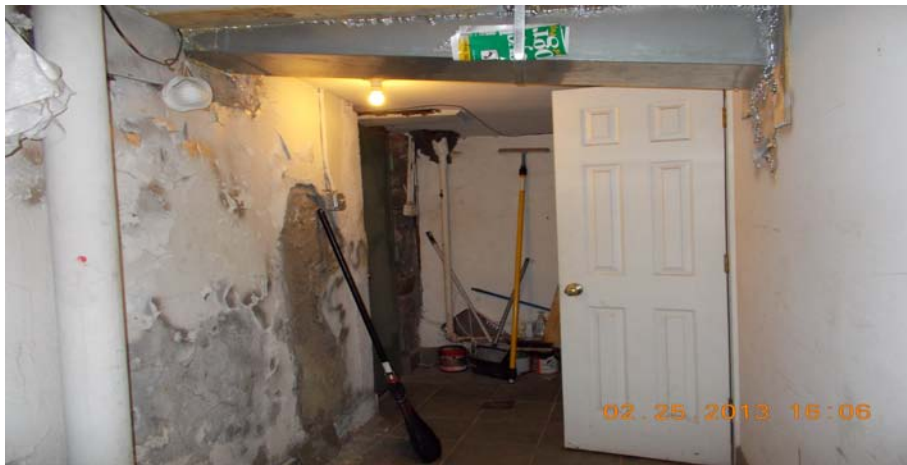
BASEMENT FRONT ENTRANCE DOOR – SPALLING FOUNDATION WALL

FRONT BASEMENT ENTRANCE AREA – FOUNDATION WALL SPALLING

Some areas of the foundation walls, where visible, were noted for spalling of masonry surfaces along with minor water seepage. See pictures. The spalled areas should be neatly removed to sound concrete surfaces and coated with waterproofing compound.

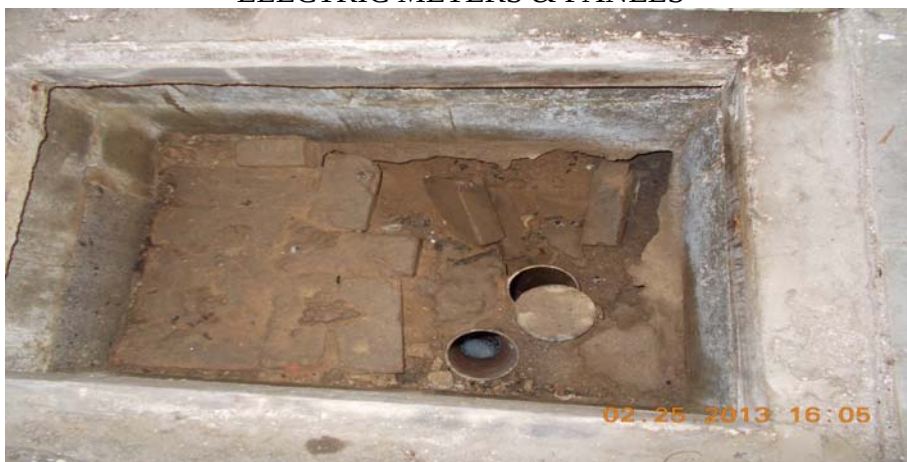
HOUSE TRAP & SEWER CLEANOUT – NEEDS COVERING CLEANOUT

The sewer main cleanout nuts inside the house trap are loose and should be completely covered and fastened to the main to avoid water backfilling into the trap.

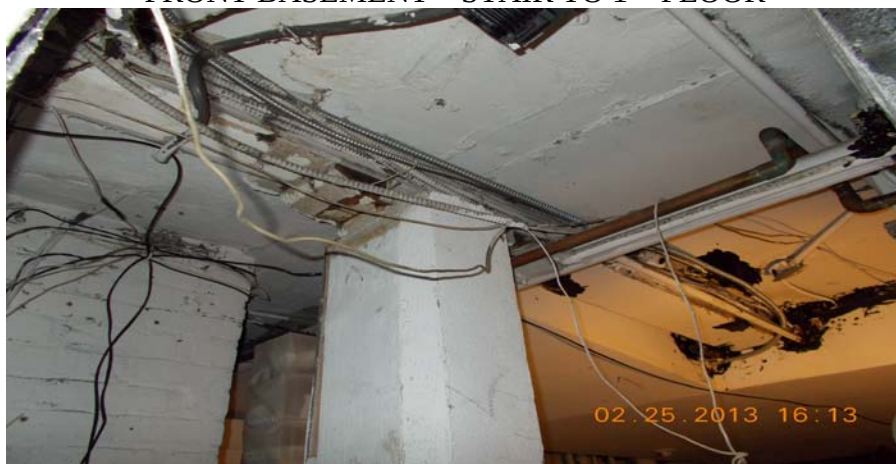
FRONT BASEMENT – COLUMN & LOOSE WIRINGS

There are many loose hanging wires inside the basement that needs securing.

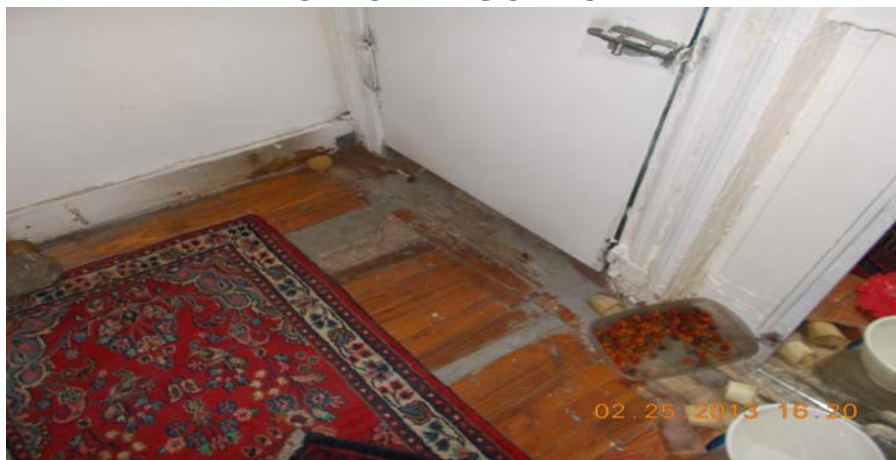
REAR BASEMENT – ROTTED & SOFT HARDWOOD FLOORING IN FRONT OF DOOR

The rear basement wooden flooring is very soft and rotted due to past/active water/termite damages. However, no active termite actions were noted. Attention will be required to the wooden flooring. The wooden flooring should be completely removed and replaced with masonry/linoleum floor tiles over concrete flooring.

The rear basement raised hardwood floorings, especially in the area of the rear entrance door, are very soft, loose and deteriorated due to past water/termite damages. Although no active termites were noted at this time, it is however, recommends termite extermination after complete removal of the wooden flooring.

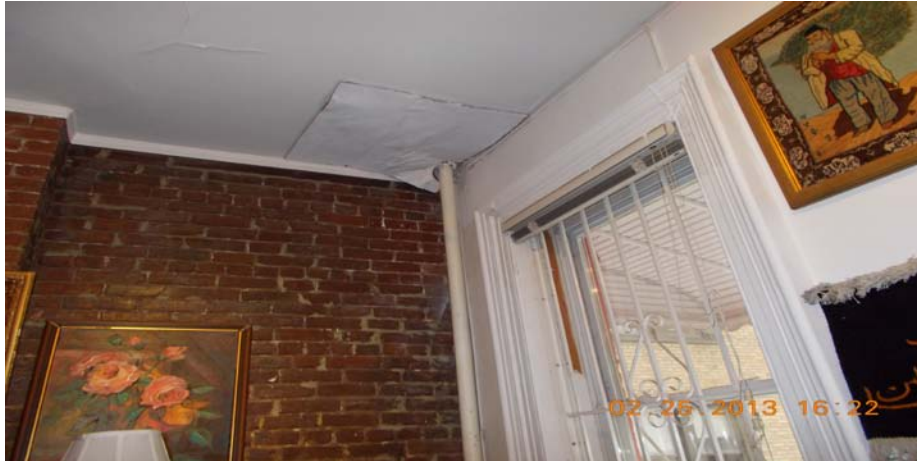
REAR 1<sup>ST</sup> FLOOR – WATER SEEPAGE ON CEILING

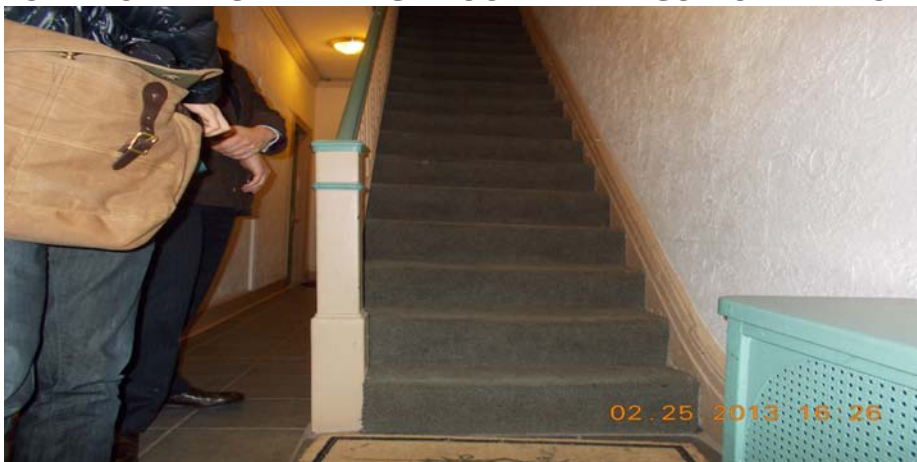
FRONT STAIR TO APARTMENTS SLIGHTLY SAGGING

The staircase to the 2<sup>nd</sup> floor is noticeably sagging toward the middle due to heavy usage and wear and tear. Although not of any structural concern at this time, however, it is recommended that the bottom of the staircase support beams be reinforced with steel posts to prevent further sagging.

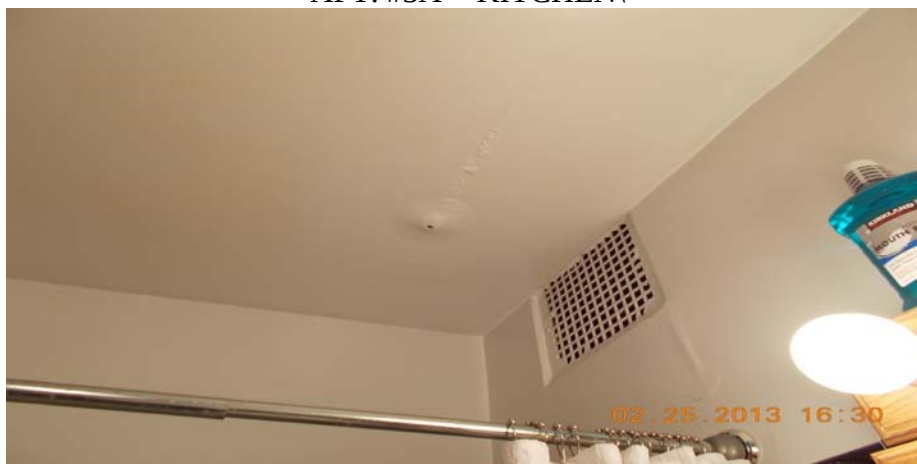
APT. #3A - BATHROOM CEILING - PAST LEAKS

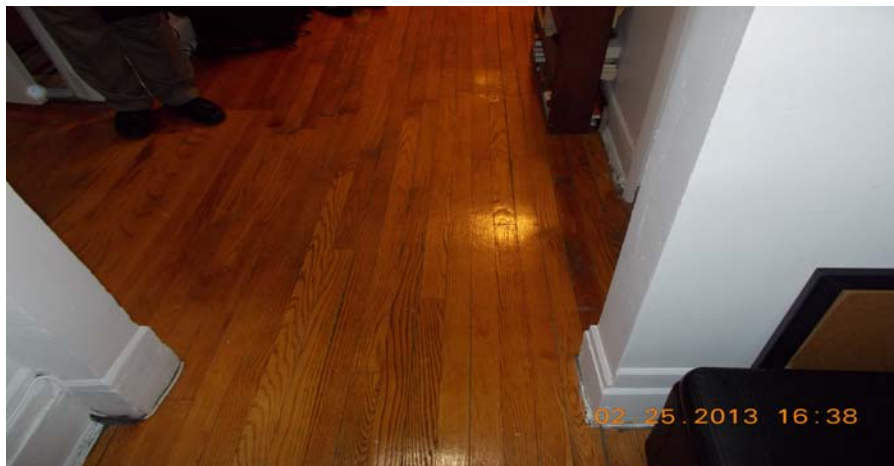
APT. #3B – HALLWAY SAGGING IN FRONT OF BATHROOM AREAS

- Floors: Mostly hardwood flooring with some ceramic floor tiles.  
Condition satisfactory and serviceable.  
Noticeable floor sags noted especially along the hallways and bathrooms.  
Needs leveling of the settled flooring where necessary.

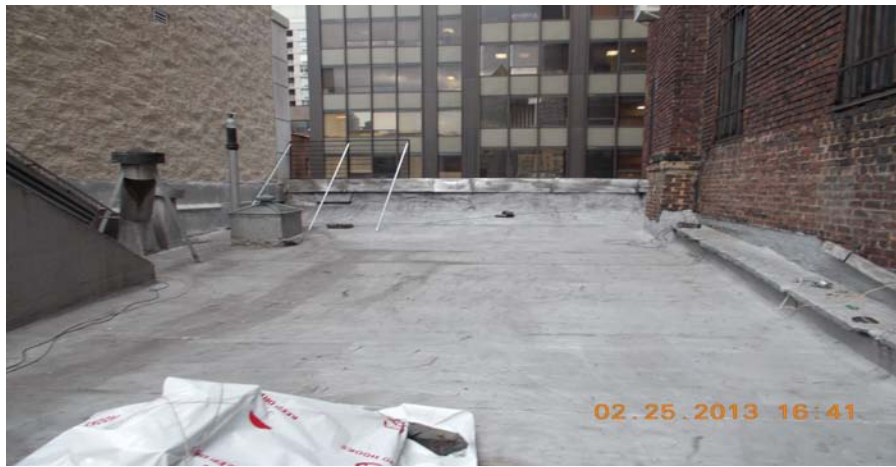
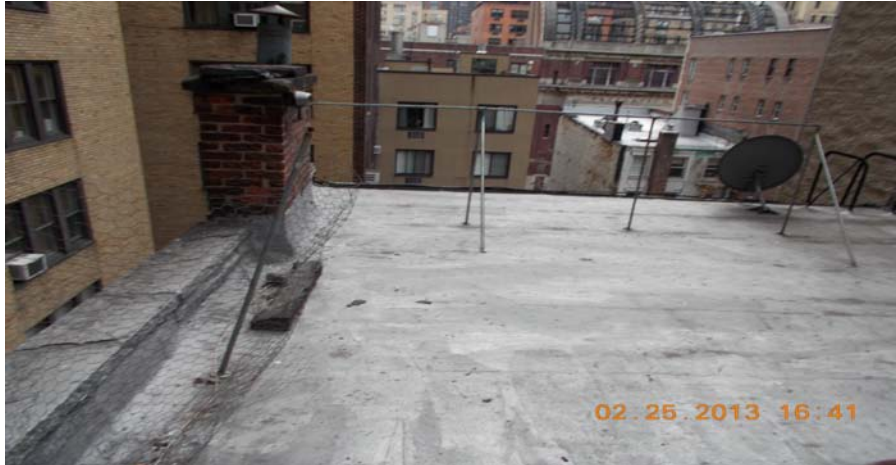
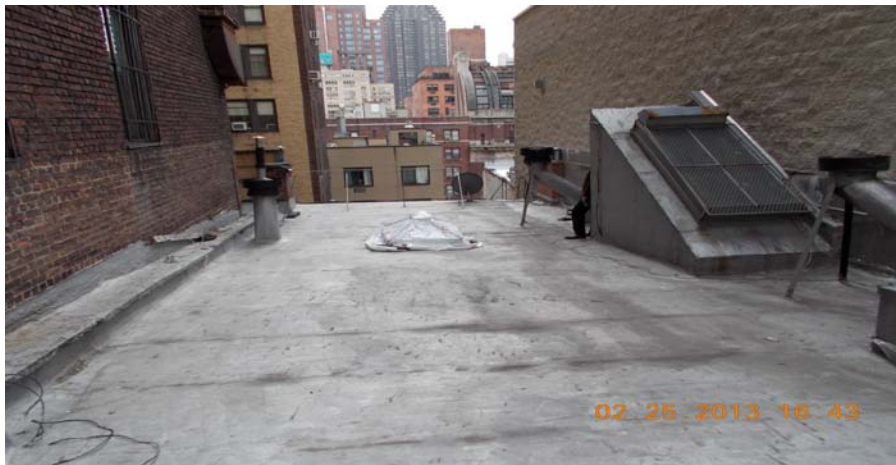
FRONT ROOFING

REAR ROOFING

ROOFING

The roofing for the building is covered with flat rubber roofing. The rubber roofing is in satisfactory condition and estimated to be about 10+- years old. See pictures.

The rubber roofing is weathering normally with minor worn off surfaces and uneven sections throughout. However, no immediate repairs are needed at this time. Needs attention.

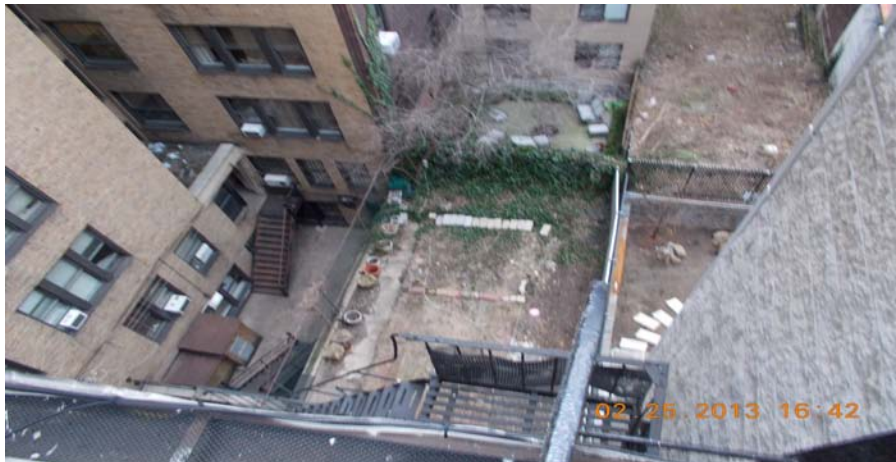
REAR YARD

The rear yard is partly paved with concrete slabs and mostly broken and needs repaving.

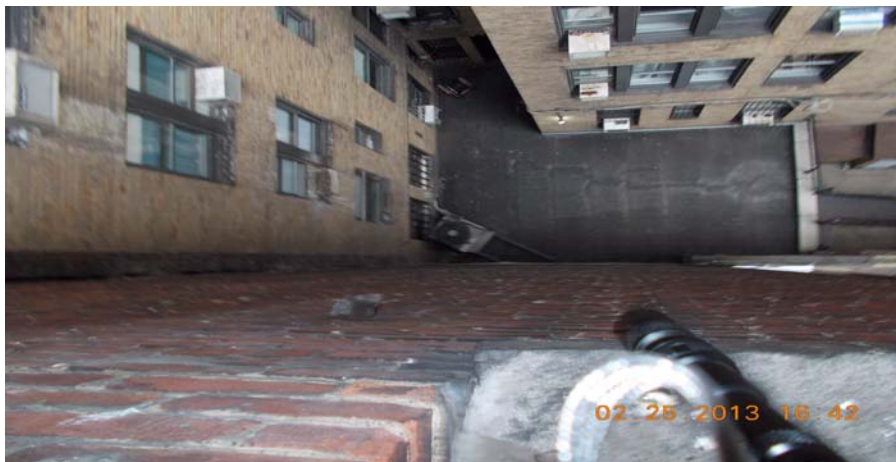
SIDE EXTERIOR WALL – WORN OFF DETERIORATED ON BRICKS

The rear portion of the left side of the building is semi-attached. The bricks on rear left side of the exterior wall show signs of excessive weathering as indicated with chipping and worn off deteriorated surfaces throughout, see picture, and would require steam-cleaning, pointing and waterproofing. This will preserve and extend the life of the bricks.

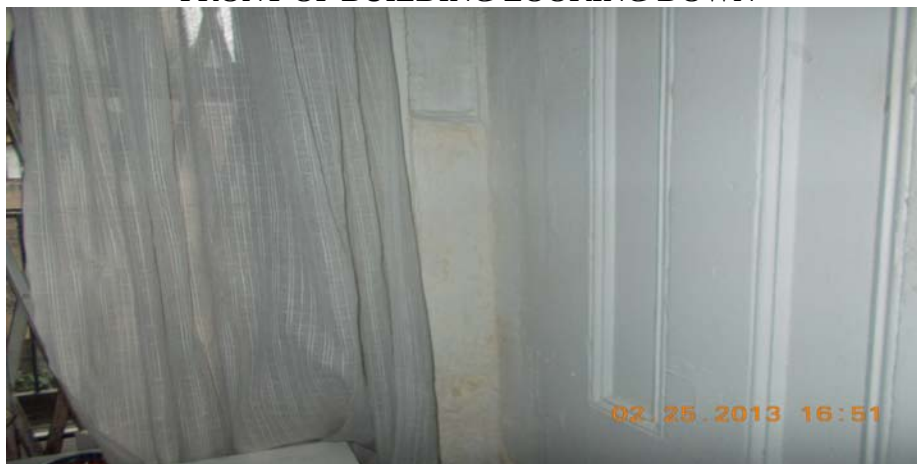
APT. # 2B – REAR KITCHEN WALL – WATER DAMAGES

- Walls: Mostly sheetrock wall paneling for the renovated apartments. The old apartments are mostly covered with plaster walls.  
Overall satisfactory condition with some cosmetic fine cracks throughout.  
Apt. #2B rear kitchen wall panel has a large section of water damaged area, see picture, and needs repair.  
Need cosmetic repairs where necessary.  
No need for other repairs.
