ENGINEER'S REPORT

**ADDRESS: 352 EAST 55TH STREET
PREPARED FOR: YING TONG REALTY LLC
DATE: FEBRUARY 25, 2013**

**DANIEL HOM, P. E.
80 ELIZABETH ST., #7B
NEW YORK, NY 10013
(718) 836-8882**

Re: Premises Inspection
352 East 55th Street
Manhattan, NY

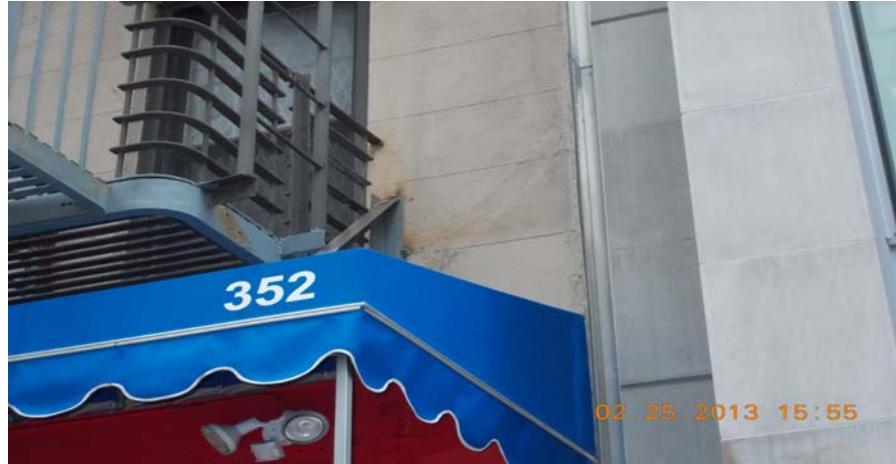
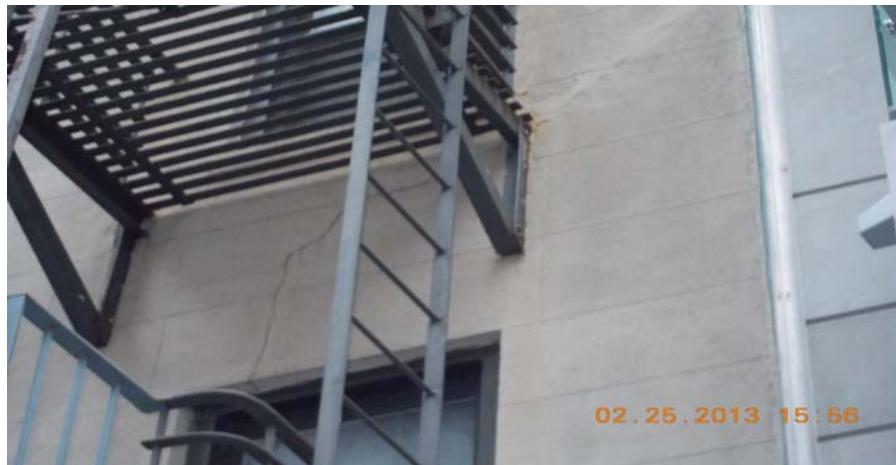
SETTLEMENT CRACKS ON FRONT EXTERIOR WALL

The front exterior wall was noted for settlement cracks especially above and below the 2nd and 3rd floor windows. See pictures. These settlement cracks are results inferior installation along with past differential settlement but of no structural concerns.
However, the open cracks and deficient areas should be completely repaired and sealed with crack sealer.

The front exterior wall appeared to be coated with a thin layer of cement overlay and overall satisfactory. However, some settlement cracks were noted on the front exterior wall as mentioned earlier. See pictures. These cracks were due to previous differential settlement and not of any structural concern. However, these cracks should be completely and neatly repaired and sealed with crack sealer.

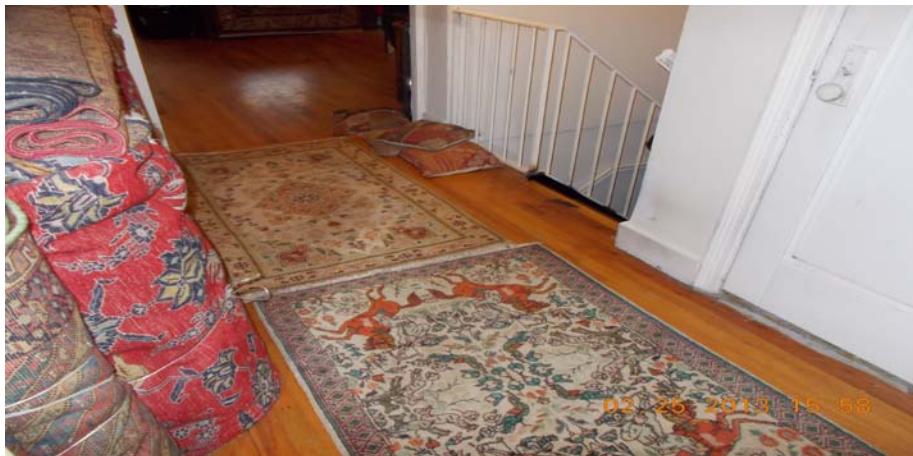
1ST FLOOR HALLWAY IN FRONT OF STAIR – NOTICEABLY SAGGING

The 1st, 2nd, 3rd and 4th floor flooring were noticeably settled especially along the apartment hallways and bathrooms are noticeably settled due to distortion/water damages to the wooden floor joists that support these areas. See pictures. The proper way to repair these areas is to remove the bathroom/hallway floorings in order to secure/replace and reinforce the wooden joists.

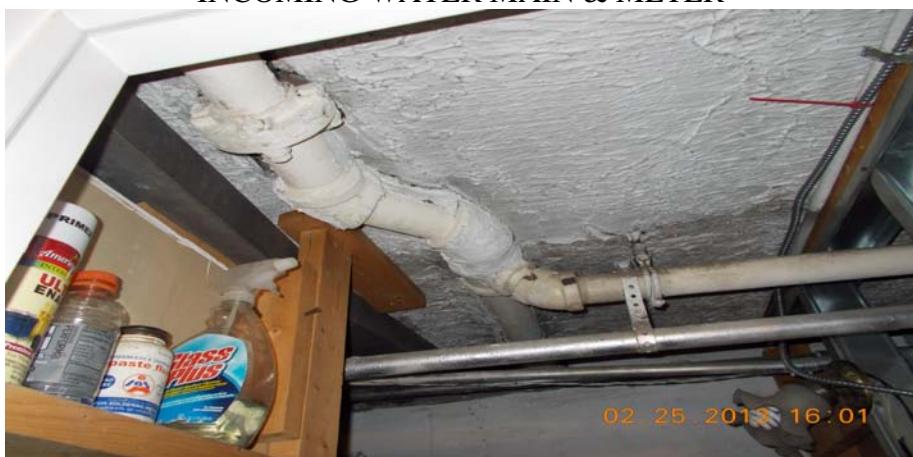
BASEMENT - ASBESTOS ON HEATING PIPES

Some sections of the overhead heating pipes are wrapped with asbestos containing insulation materials. See picture. As a safety concern, the asbestos insulation should be properly removed and disposed of.

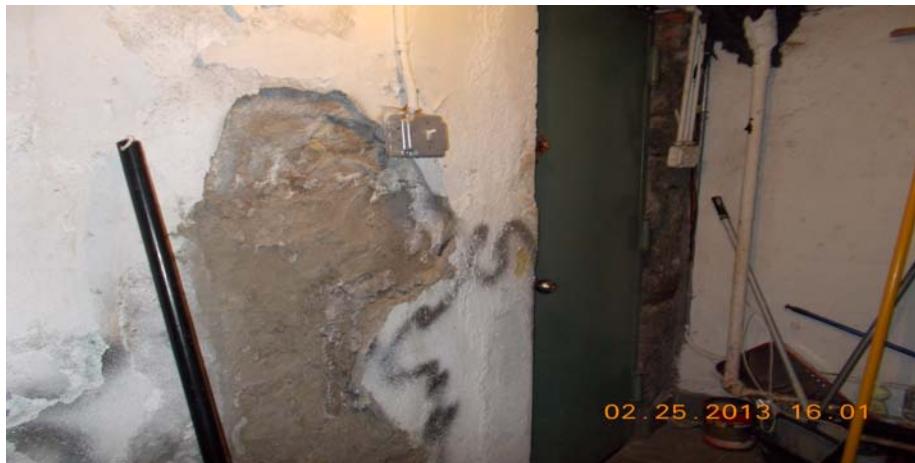
BASEMENT FRONT ENTRANCE DOOR – SPALLING FOUNDATION WALL

Some areas of the foundation walls, where visible, were noted for spalling of masonry surfaces along with minor water seepage. See pictures. The spalled areas should be neatly removed to sound concrete surfaces and coated with waterproofing compound.

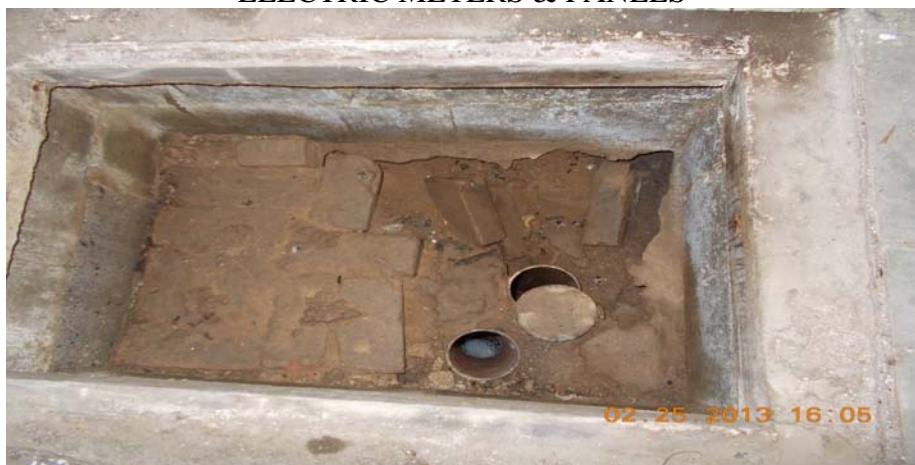
HOUSE TRAP & SEWER CLEANOUT – NEEDS COVERING CLEANOUT

The sewer main cleanout nuts inside the house trap are loose and should be completely covered and fastened to the main to avoid water backfilling into the trap.

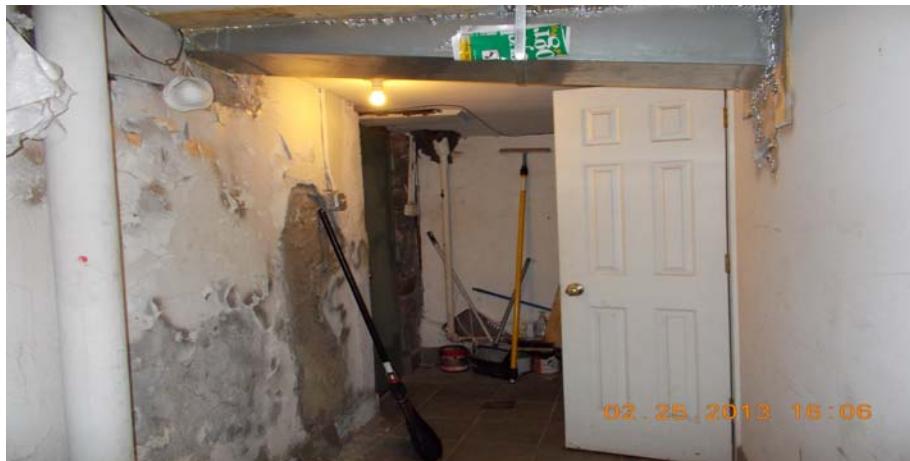
FRONT BASEMENT ENTRANCE AREA – FOUNDATION WALL SPALLING

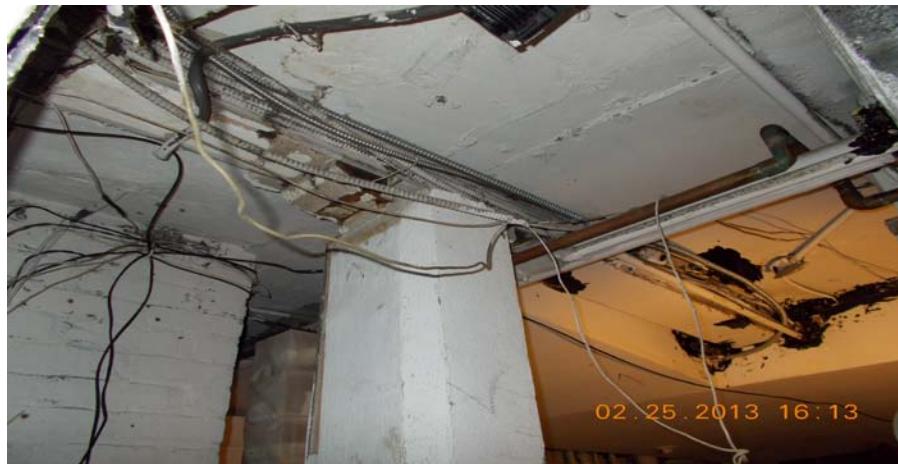
FRONT BASEMENT - COLUMN & LOOSE WIRINGS

There are many loose hanging wires inside the basement that needs securing.

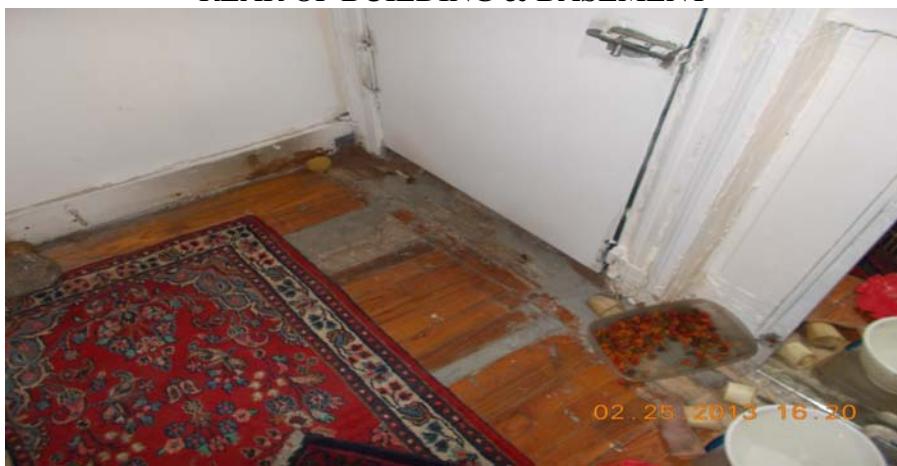
REAR BASEMENT – ROTTED & SOFT HARDWOOD FLOORING IN FRONT OF DOOR

The rear basement wooden flooring is very soft and rotted due to past/active water/termite damages. However, no active termite actions were noted. Attention will be required to the wooden flooring. The wooden flooring should be completely removed and replaced with masonry/linoleum floor tiles over concrete flooring.

The rear basement raised hardwood floorings, especially in the area of the rear entrance door, are very soft, loose and deteriorated due to past water/termite damages. Although no active termites were noted at this time, it is however, recommends termite extermination after complete removal of the wooden flooring.

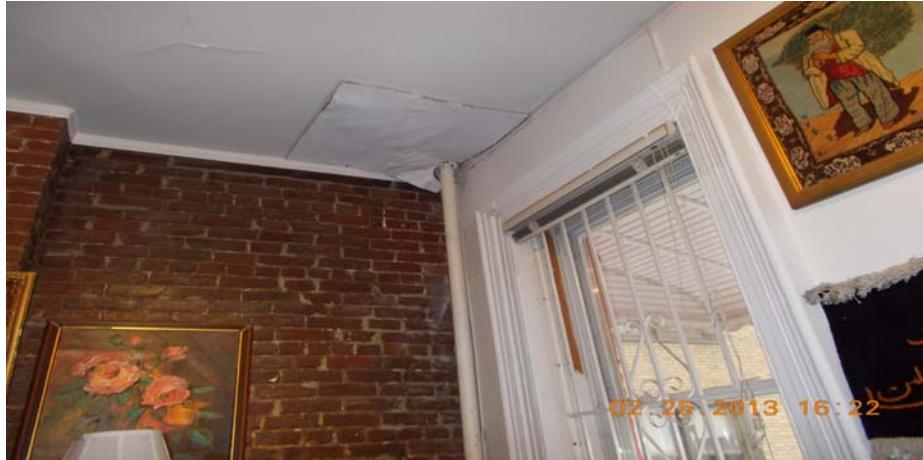
REAR 1ST FLOOR – WATER SEEPAGE ON CEILING

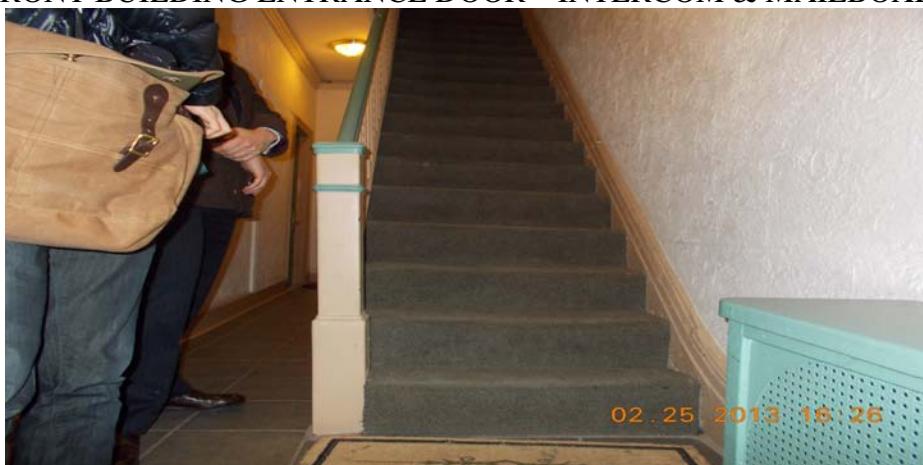
FRONT STAIR TO APARTMENTS SLIGHTLY SAGGING

The staircase to the 2nd floor is noticeably sagging toward the middle due to heavy usage and wear and tear. Although not of any structural concern at this time, however, it is recommended that the bottom of the staircase support beams be reinforced with steel posts to prevent further sagging.

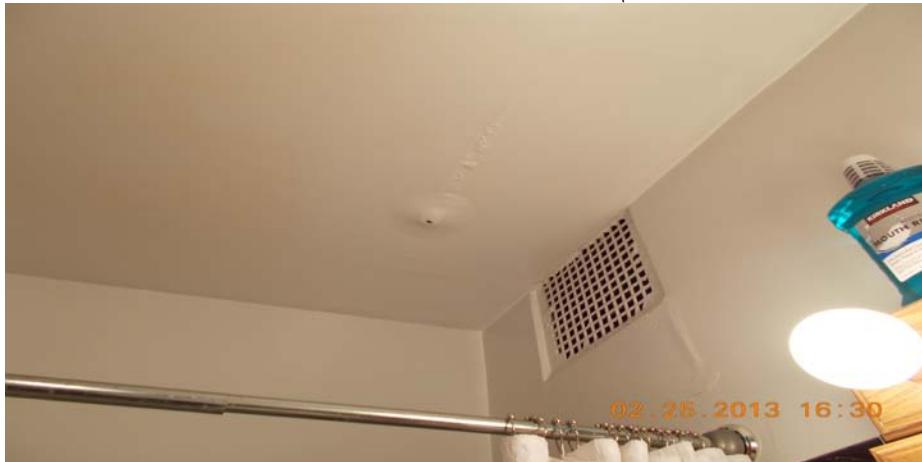
APT. #3A – BATHROOM CEILING – PAST LEAKS

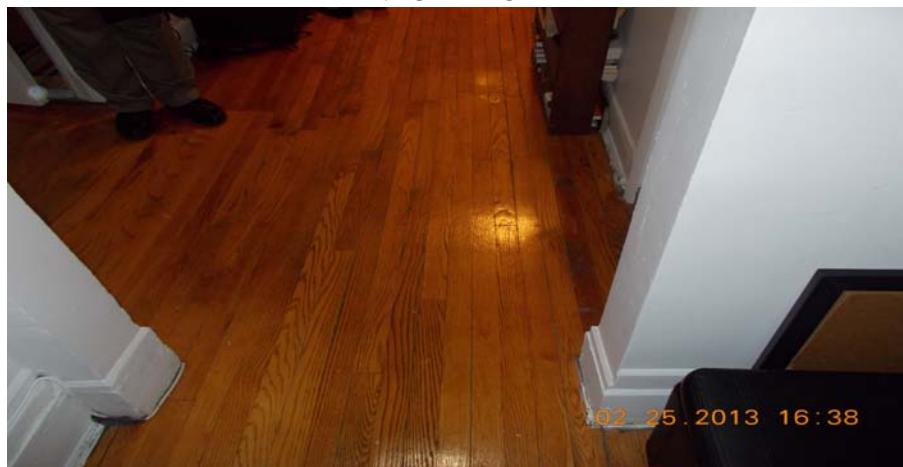
APT. #3B – HALLWAY SAGGING IN FRONT OF BATHROOM AREAS

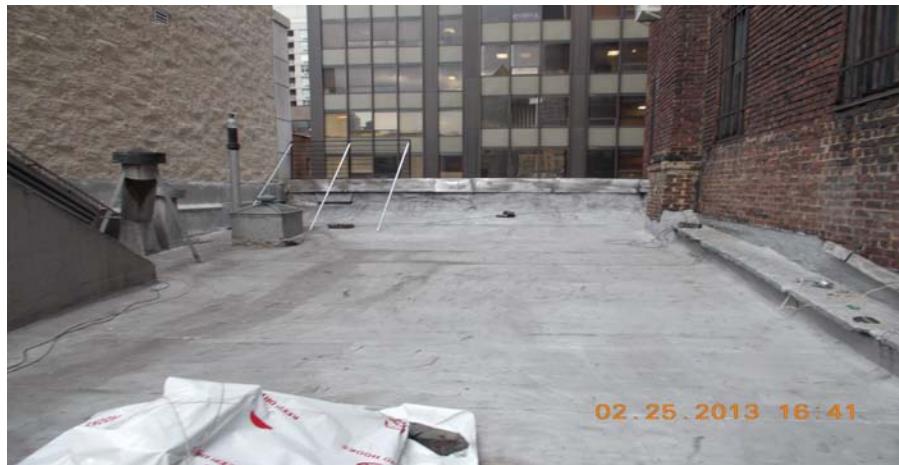
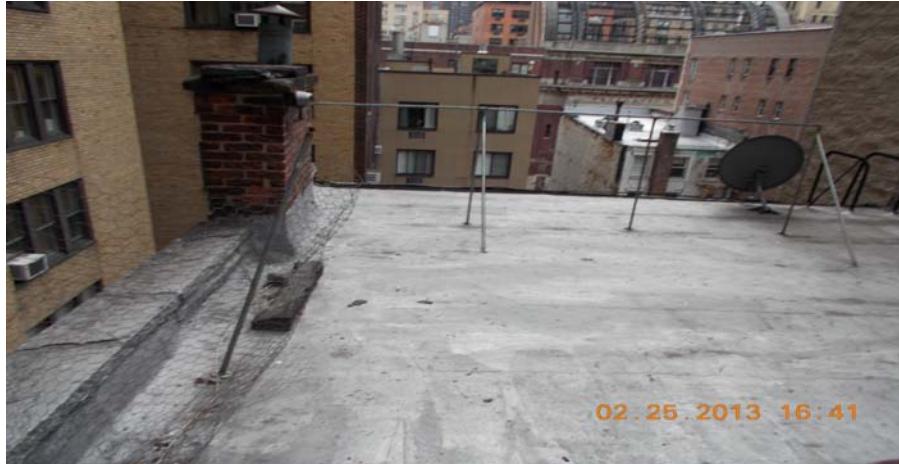
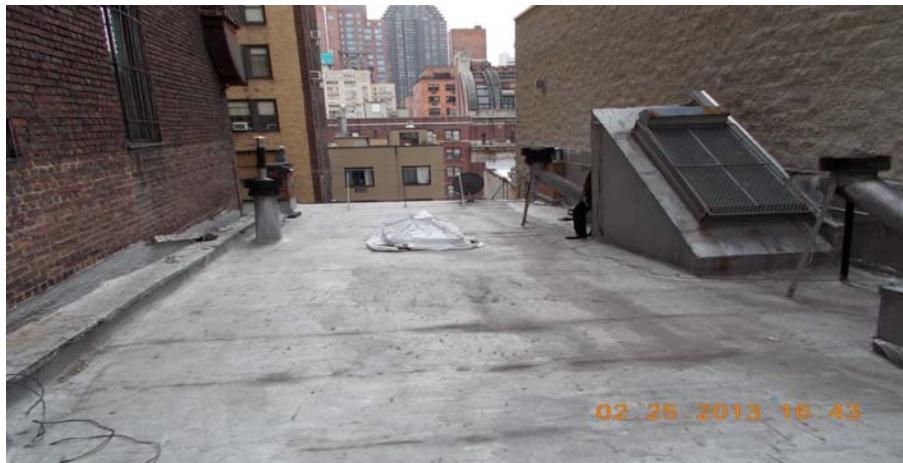
FRONT ROOFING

REAR ROOFING

ROOFING

The roofing for the building is covered with flat rubber roofing. The rubber roofing is in satisfactory condition and estimated to be about 10+- years old. See pictures.

The rubber roofing is weathering normally with minor worn off surfaces and uneven sections throughout. However, no immediate repairs are needed at this time. Needs attention.

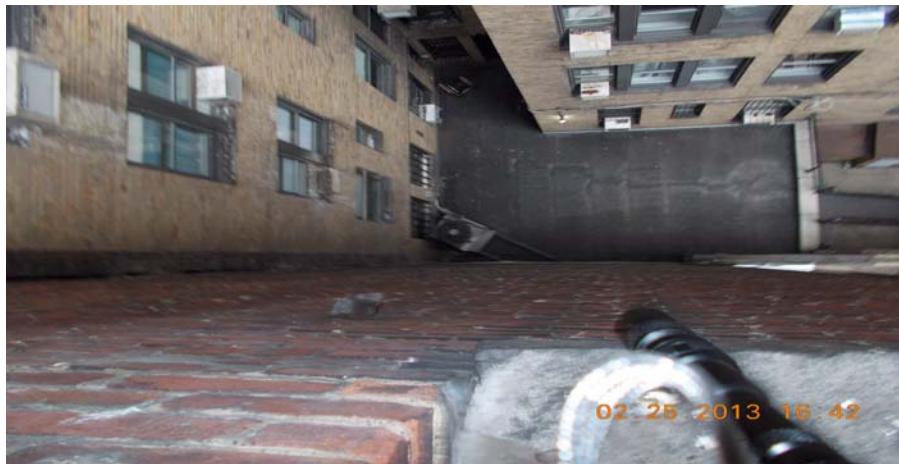
SIDE EXTERIOR WALL – WORN OFF DETERIORATED ON BRICKS

The rear portion of the left side of the building is semi-attached. The bricks on rear left side of the exterior wall show signs of excessive weathering as indicated with chipping and worn off deteriorated surfaces throughout, see picture, and would require steam-cleaning, pointing and waterproofing. This will preserve and extend the life of the bricks.

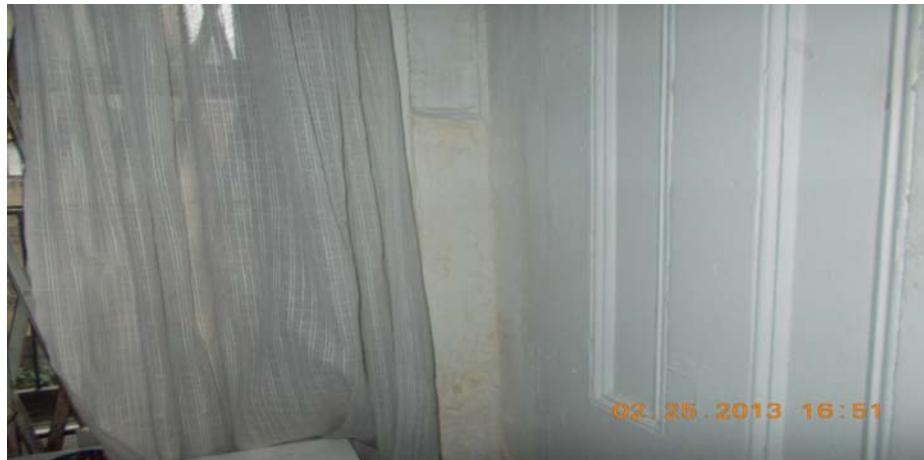
APT. # 2B – REAR KITCHEN WALL – WATER DAMAGES

Walls: Mostly sheetrock wall paneling for the renovated apartments. The old apartments are mostly covered with plaster walls. Overall satisfactory condition with some cosmetic fine cracks throughout. Apt. #2B rear kitchen wall panel has a large section of water damaged area, see picture, and needs repair. Need cosmetic repairs where necessary. No need for other repairs.
